OSHA's Fire Service Features of Buildings: Commentary on an OSHA Publication Pertaining to Wood Trusses

Released July 6, 2007

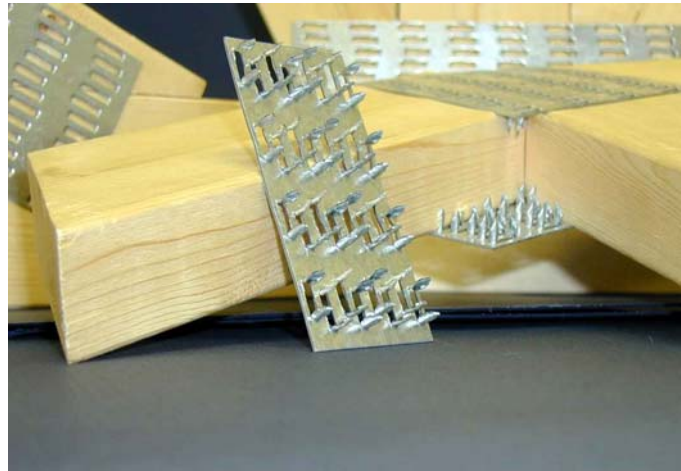
Photo 1

Metal connector plate⁴: Connector plate manufactured from ASTM A653/A653M, A591, A792/A792M, or A167 structural quality steel protected with zinc or zinc-aluminum alloy coatings or their stainless steel equivalent. The metal connector plate has integral teeth and shall be manufactured to various sizes (i.e., length and width) and thickness or gauges and shall be designed to laterally transmit loads in wood. Also known as truss plate, plate, metal plate, etc. (see Photo 1)

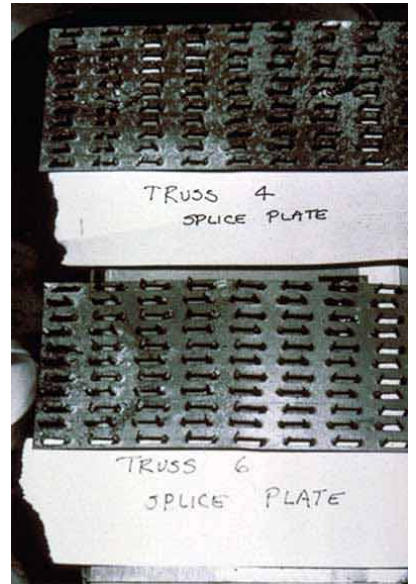
As an example, the connector plates in Photo 2 were exposed to an ASTM E119 test fire that burned for 60 minutes and reached 1700 degrees Fahrenheit. The plates show no visible signs of distress, and they look no different from normal plates other than the charred wood remaining on the teeth, and discoloration from having been exposed to extremely high temperatures.

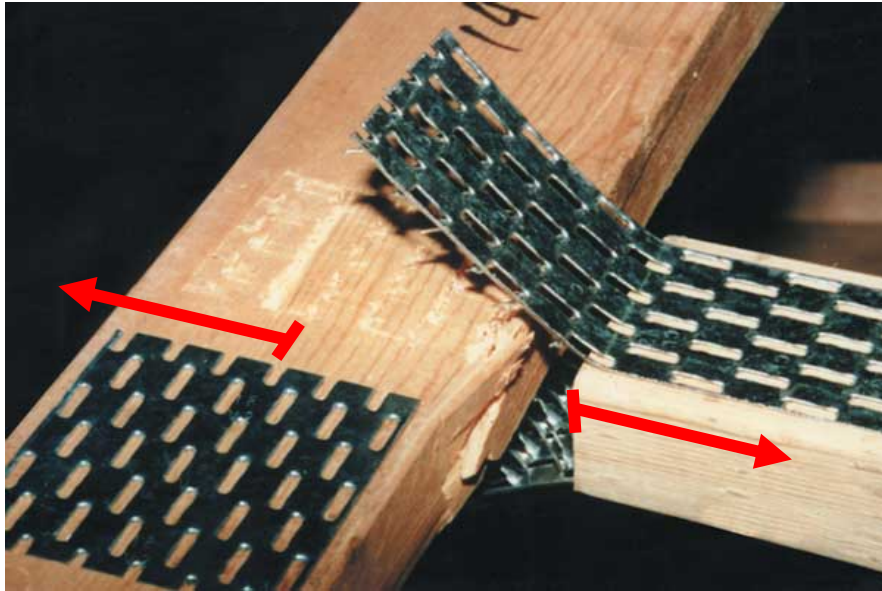
Photo 3

Truss joints typically fail as the fire degrades wood members they are connecting together the same way they fail under excessive loads – in withdrawal resistance failure mode. This failure mode is shown in Photo3 in which the two wood members were pulled apart with enough force to cause joint failure.

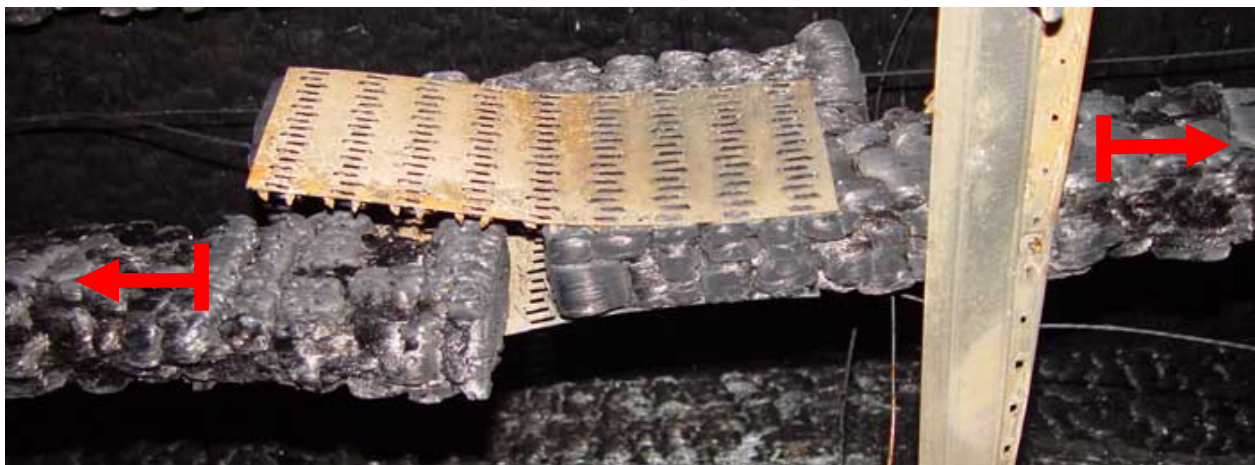
Photo 4

This failure mode can also be seen with this charred bottom chord splice joint in a truss (see Photo 4). The plate pulled out of the wood due to the forces exerted on it by the members pulling apart as shown. Note the characteristic curled shape taken by the connector plate in the withdrawal resistance failure mode.

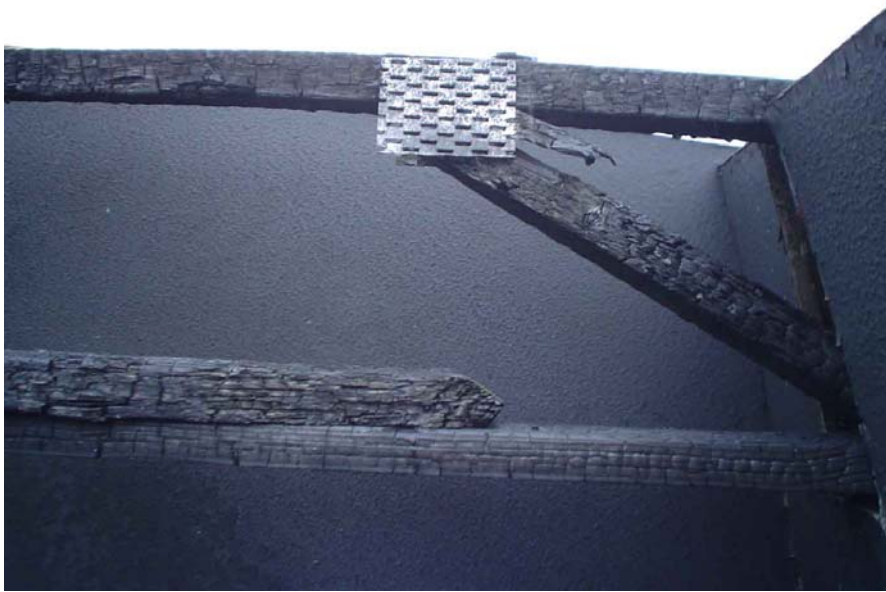
Photo 5

If charring occurs in fire but the withdrawal forces are not great enough, connector plates can stay connected even after significant charring, as you can see in Photo 5.

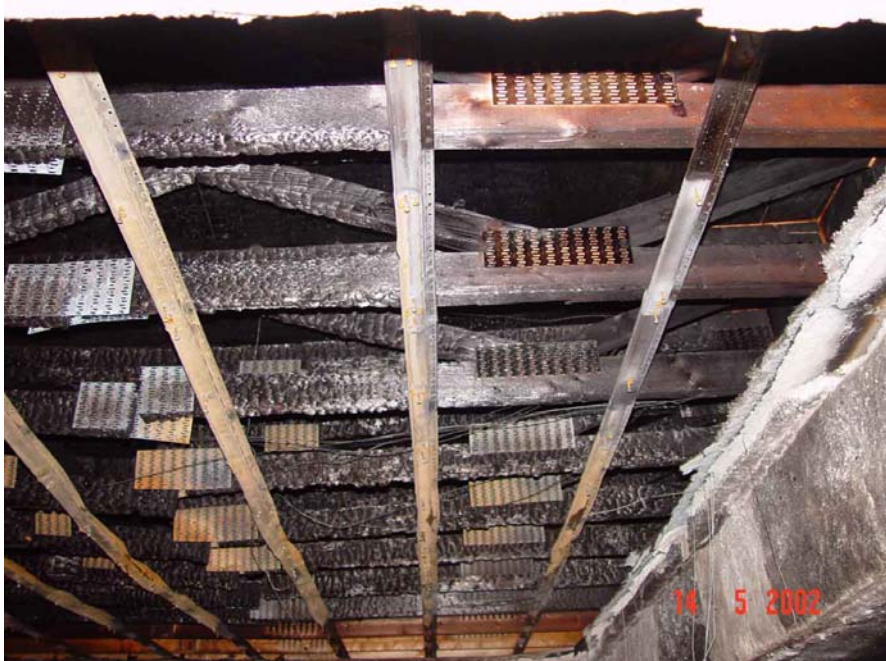
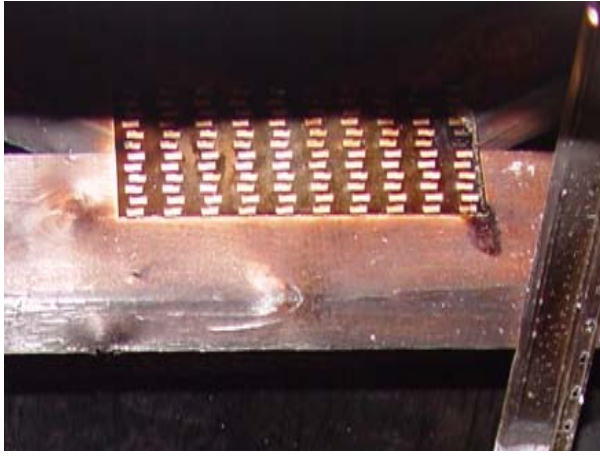
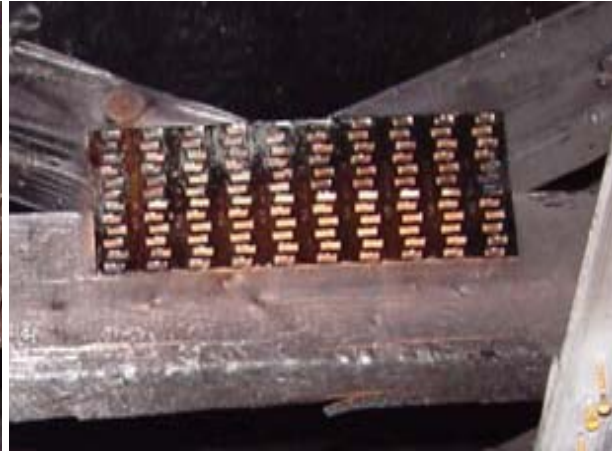
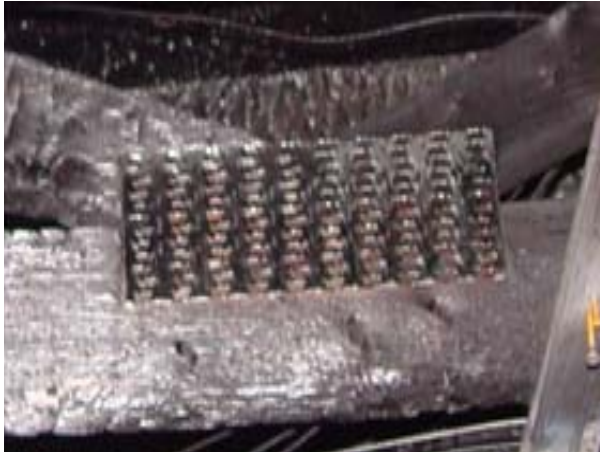
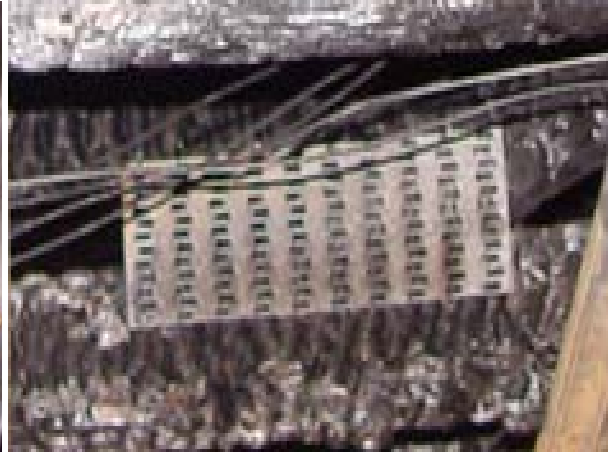
These concepts are described more fully in the Carbeck Education Program *Wood Truss Construction and Fire Performance*¹⁵ and can be seen below in the following series of photographs of connector plates at successively greater fire exposures (see Photos 6 – 10). These photos come from a test fire where parts of the floor assembly happened to receive differing degrees of fire exposure, as evidenced by the increasing amounts of char seen on the joists toward the back of this assembly.

Another common misperception is that metal connector plates help promote failure in fire by accelerating char on the wood below them. As can be seen in the preceding photos, the truss plates do protect the wood for a period of time prior to becoming a heat conductor. This is due to the moisture in the lumber below the plate. According to Canadian fire researcher Leslie Richardson:

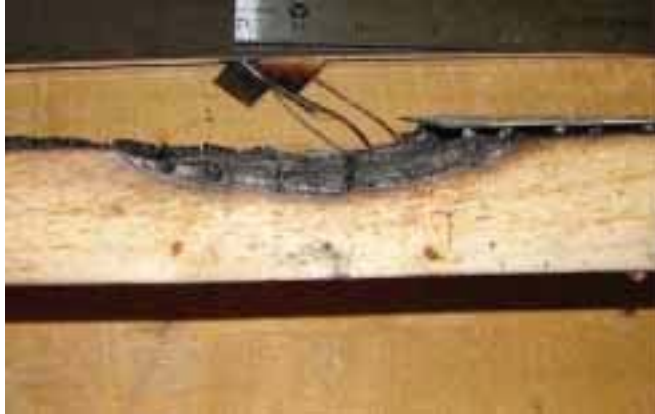
This concept is also more fully described in the Carbeck Educational Program¹⁷ entitled *Fire Performance of Metal Connector Plates* and can be seen in Photos 11 and 12:

Photo 11
Courtesy NIST and Kelly Harman¹⁸

¹⁸ From a draft thesis entitled “A Study of Metal Truss Plate Connectors When Exposed to Fire” by Kelly Harman, E.I.T and James Lawson, 2005. This was based on research done at the National Institute of Standards and Technology in 2005.

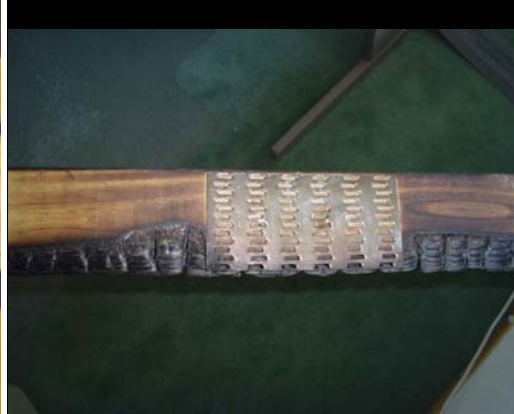
Photo 12
Result of Fire Barrel demonstration¹⁹

¹⁹ This photo shows a splice joint which had been exposed to fire over a barrel. This was done as part of a demonstration conducted during a truss plant tour for firefighters in Nashville, TN.

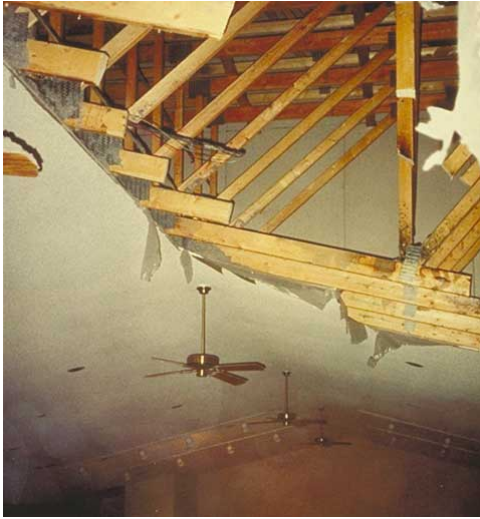
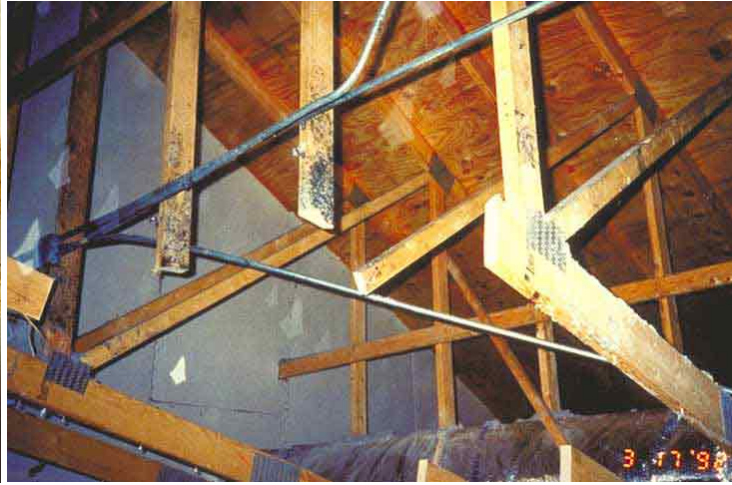
When a member or joint in a metal plate connected wood truss is broken, the truss loses much of its strength, but it retains some of its load carrying capacity. This is due to the moment carrying capacity of the metal plate connected joints, and the ability of the nearby members and joints of a truss to share loads.²¹ This concept is also more fully described in the Carbeck Educational Program²², entitled *Wood Trusses after a Church Fire*, and can be seen in the Photos 13 and 14:

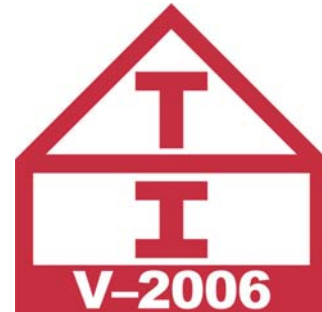
In this example (see Photo 15), the top letter “T” denotes truss construction in the roof. The lower letter “I” denotes wood I-joint construction in the floors. Other construction types that could be indicated in this

Where there is resistance to putting in place an easy to implement and use pre-fire planning system, *universal* building labeling may be an option to be considered. In this second choice, all construction types in all buildings need to be labeled. This would provide all the information that firefighters need to guide fireground decision making and not mislead them.³⁸ Photo 15 provides an example of a label in such a labeling system.
