**Fire Assemblies:
Performance and Application Using
Wood Trusses**

Overview

Revised 2/24/2017

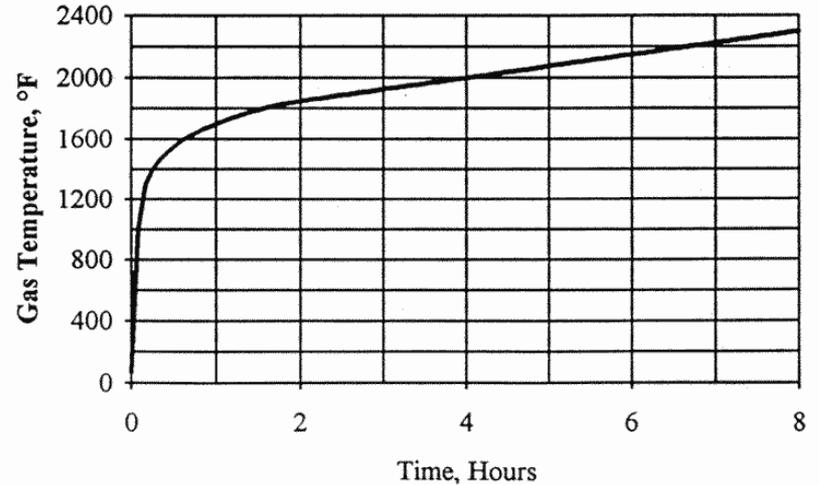
ASTM E119 Time/Temperature Curve

- In the test:
 - A representative assembly is constructed for each assembly to be tested.
 - The assembly is put under full design load, then burned following the ASTM time temperature curve.

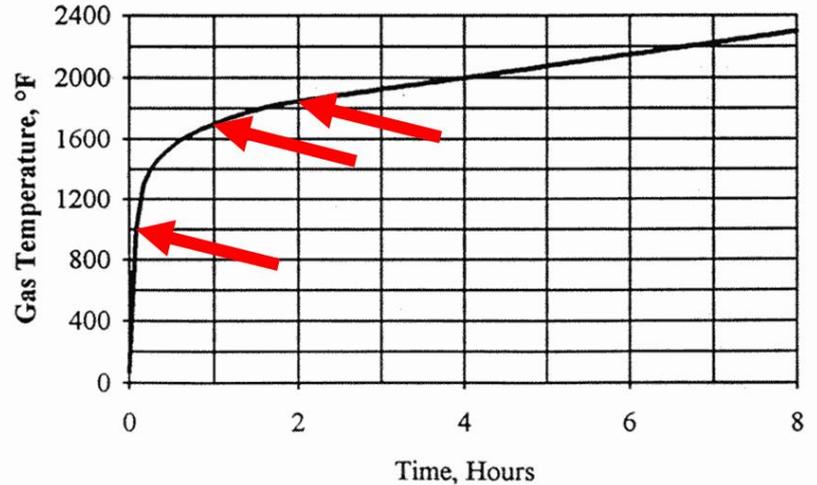
ASTM E119 Time/Temperature Curve

- In the first 5 minutes, the temperature increases to about 1000° F (**left arrow**)
- By 60 minutes into the test, the temperature increases to about 1700° F . (**middle arrow**)
- If the assembly needs to be tested for two hours, the temperature continues to increase up to 1800° F during the next hour. (**right arrow**)

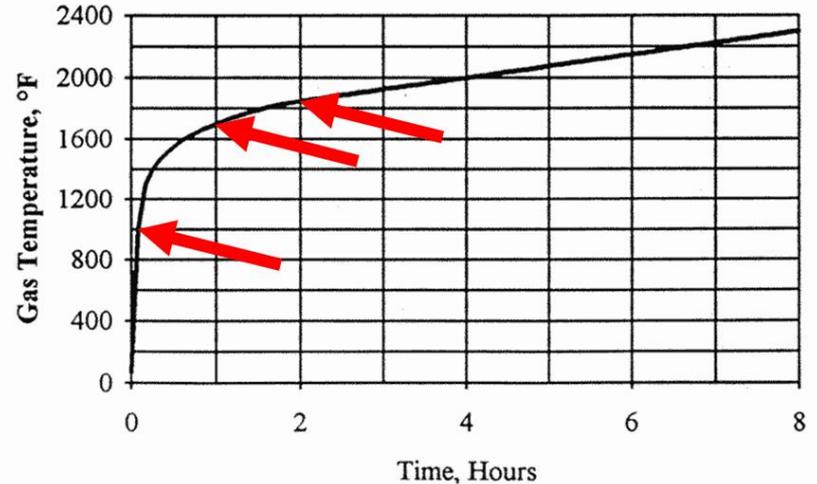
ASTM E119 Time/Temperature Curve

- The test furnace follows this time temperature curve as accurately as possible.
 - ASTM E119 has a formula to adjust endurance times if the furnace is to hot or too cool.
- This is a very severe test.
 - First, because of the rapid increase to 1000° F.
 - Second, because the temperature continues to increase until the assembly fails.

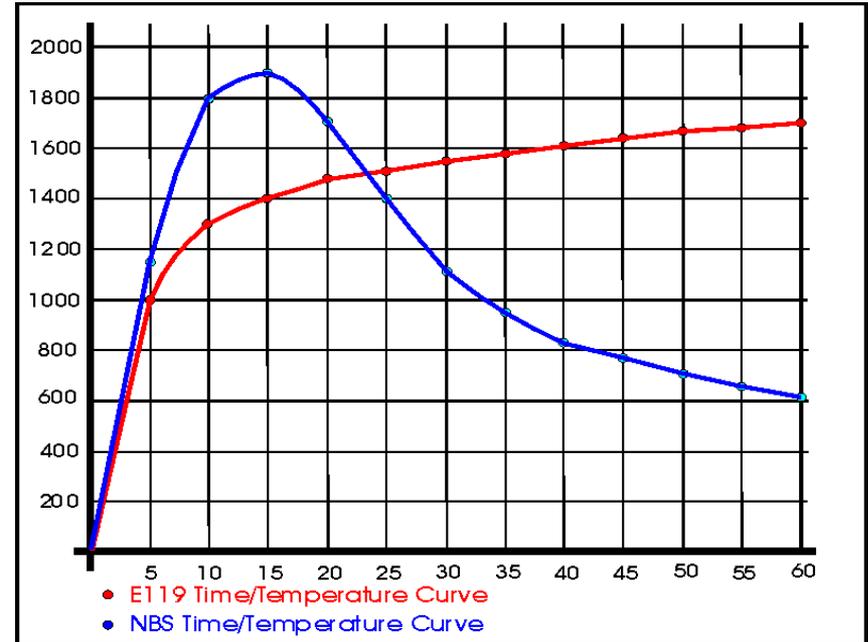
- Compare the NBS curve (blue) to the ASTM E119 curve (red).
- They are similar in the first 5 minutes where the temperature is about 1000° F
- The NBS curve increases to roughly 1800° F over the next five minutes, then drops off over the next 45 minutes, with the temperature falling to about 800° F by the 60 minute point.
- It is likely that if this time-temperature curve was used, assemblies would endure fire for longer periods of time than are seen in ASTM E119 tests due the severity differences — NBS high early, ASTM high to the end.

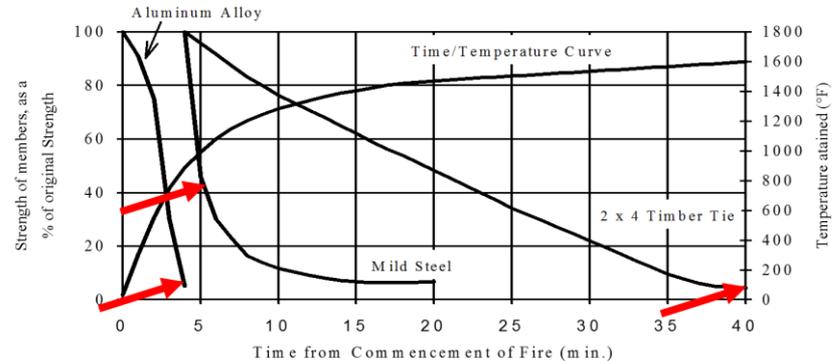
- Testing was undertaken on various materials using the ASTM time temperature curve to compare the performance of unprotected structural materials:
 - The aluminum member fails in about 4 minutes
 - Mild steel loses yield strength rapidly in 5 minutes, is at 20% of its strength at 7 minutes and fails in 20 minutes
 - The 2x4 is at 20% of its strength at 30 minutes and fails at 40 minutes.

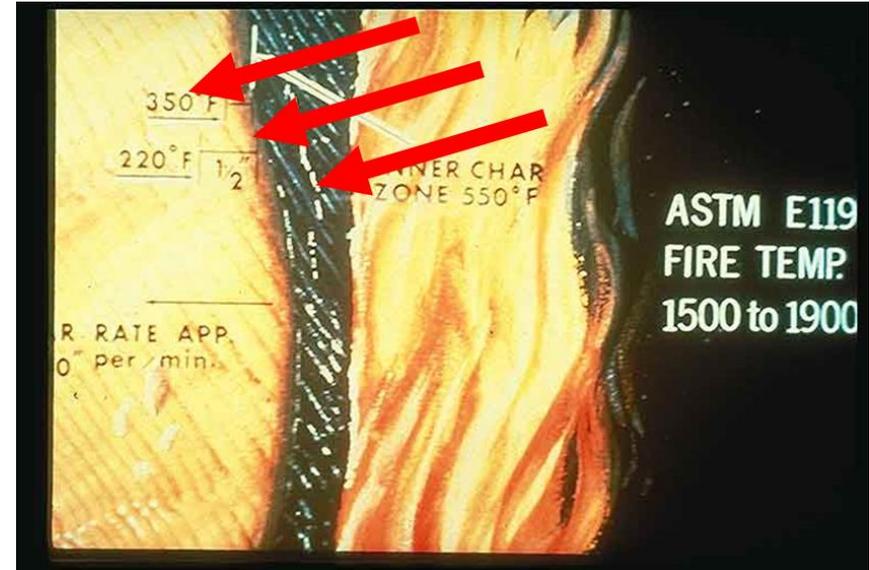
- As the wood burns a char layer is developed that protects the wood below this layer of char from degrading.
- Recall that under ASTM E119 testing conditions the temperature of the testing furnace goes from 0 to 1000° F in 5 minutes and then increases more slowly until it reaches 1700° F at 60 minutes.
- The charring rate of wood is a valuable fire protection feature of this engineering material.
 - The temperature at the inside of the char zone is 550° F
 - $\frac{1}{4}$ " in the temperature is only 350° F
 - $\frac{1}{2}$ " in the temperature is only 220° F

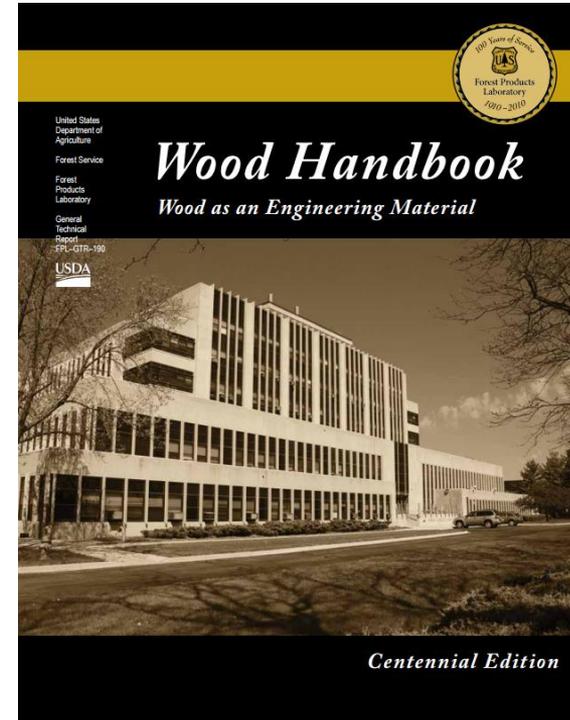
- Under ASTM E119 fire test exposures, wood ignites in approximately two minutes.
- According to Forest Products Laboratory, "Wood Handbook: Wood as an Engineering Material,"
 - Charring then proceeds at a rate of 1/30 inch per minute for the next eight minutes
 - Thereafter, the char layer has an insulating effect, and the rate decreases to 1/40 inch per minute after 8 minutes
 - This translates to about 1-1/2 inches of charring per hour of burning, depending on the species of wood

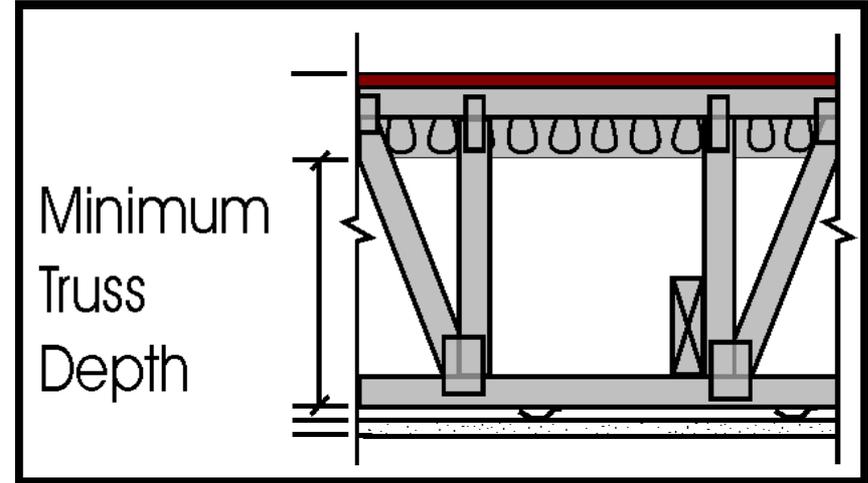
- In assemblies tested with insulation
 - Follow tested assembly
- In assemblies tested without insulation
 - Evaluate impact
 - Place away from gypsum
 - Plenum depth greater or equal to tested

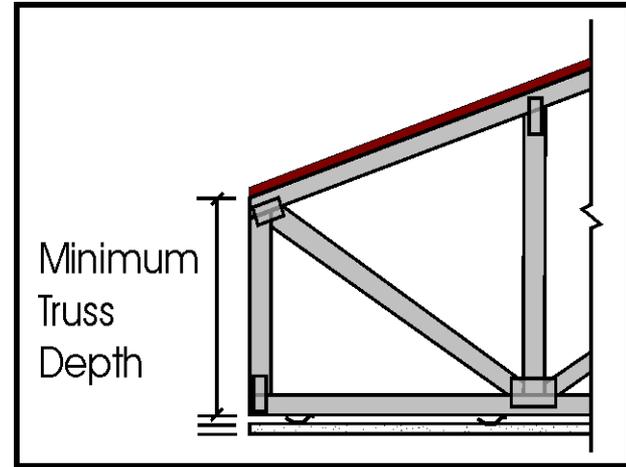
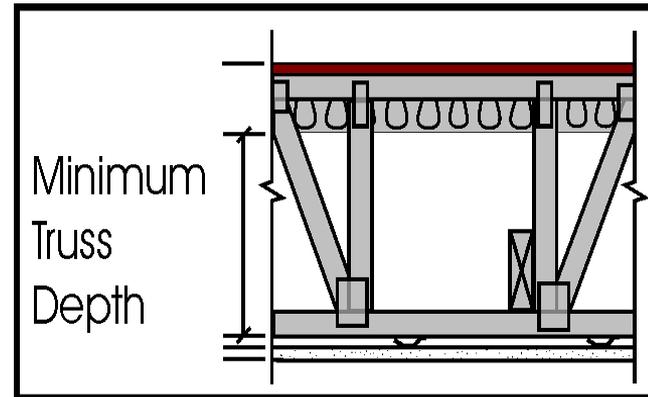
- Depth of Assembly
 - Minimum depth given
 - Increasing depth may enhance assembly performance
- Pitched vs. Flat assemblies
 - As long as minimum depth is maintained

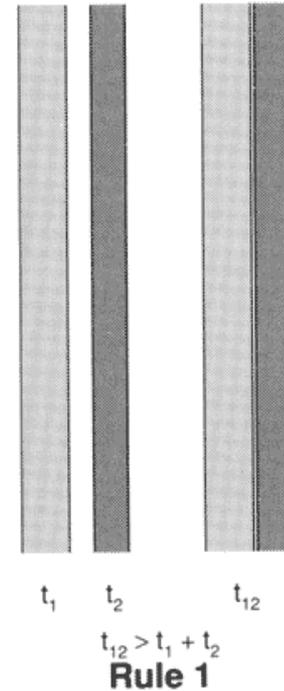
- The thermal fire endurance of a construction consisting of a number of parallel layers is greater than the sum of the “thermal” fire endurance characteristics of the individual layers when exposed separately to a fire.

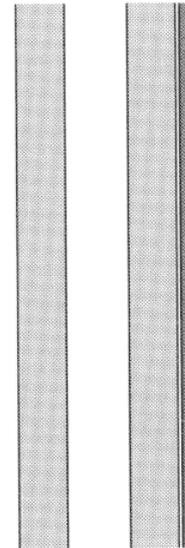
t_1 t_2
 $t_2 > t_1$
Rule 2

- The fire endurance of a construction does not decrease with the addition of further layers.

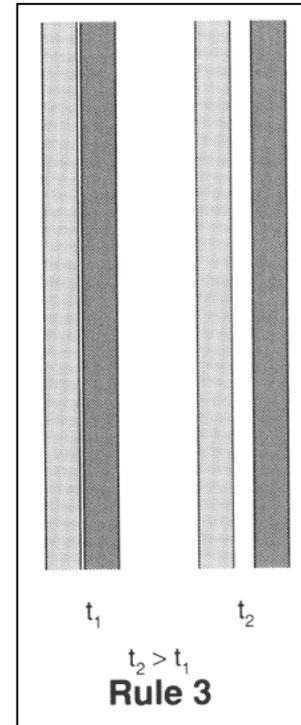
- The fire endurance of constructions that contain continuous air gaps or cavities is greater than the fire endurance of similar constructions of the same weight, but containing no gaps or cavities.

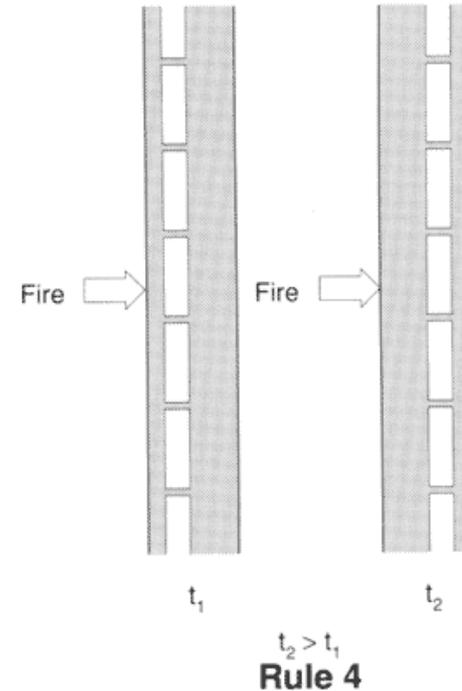
- The farther an air gap or cavity is located from the exposed surface, the more beneficial is its effect on fire endurance.

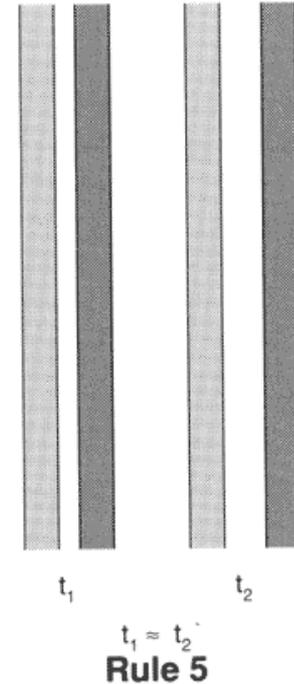
- Increasing the thickness of a completely enclosed air layer cannot increase the fire endurance of a construction.

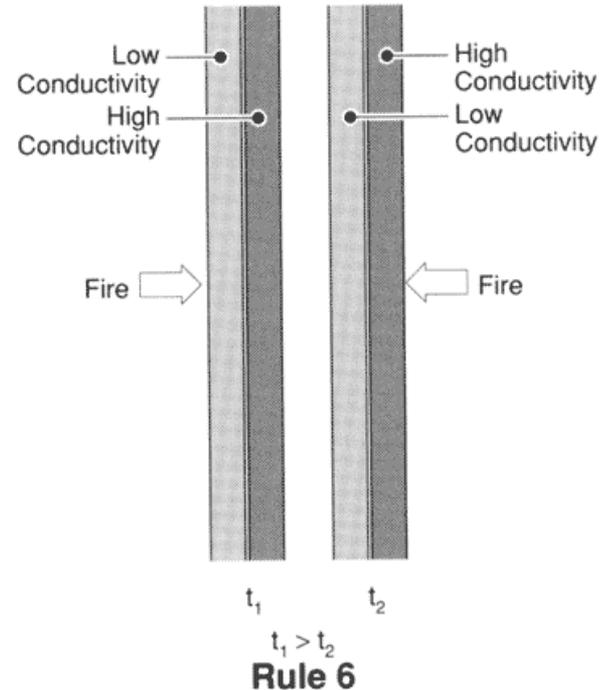
- Layers of materials of low thermal conductivity are better utilized on that side of the construction on which fire is more likely to happen.

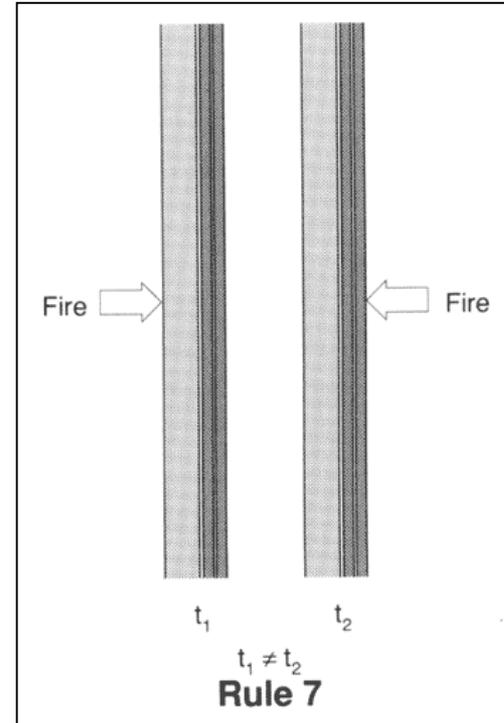
- The fire endurance of asymmetrical constructions depends on the direction of heat flow.

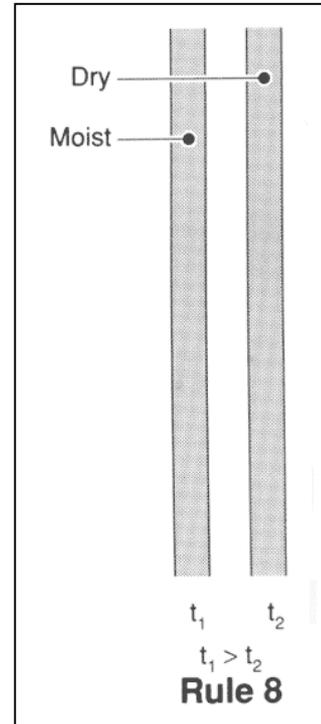
- The presence of moisture, if it does not result in explosive spalling, increases the fire endurance.

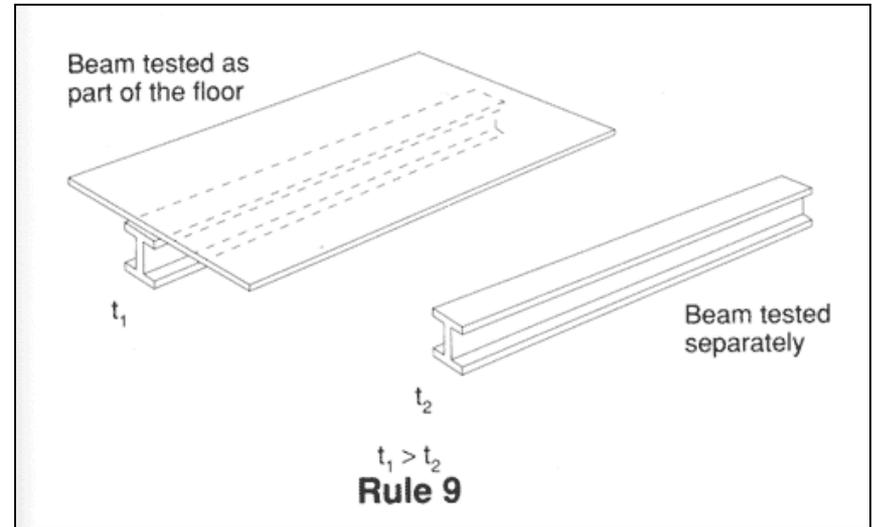
- Load-supporting elements, such as beams, girders and joists, yield higher fire endurance's when subjected to fire endurance tests as parts of floor, roof, or ceiling assemblies than they would when tested separately.

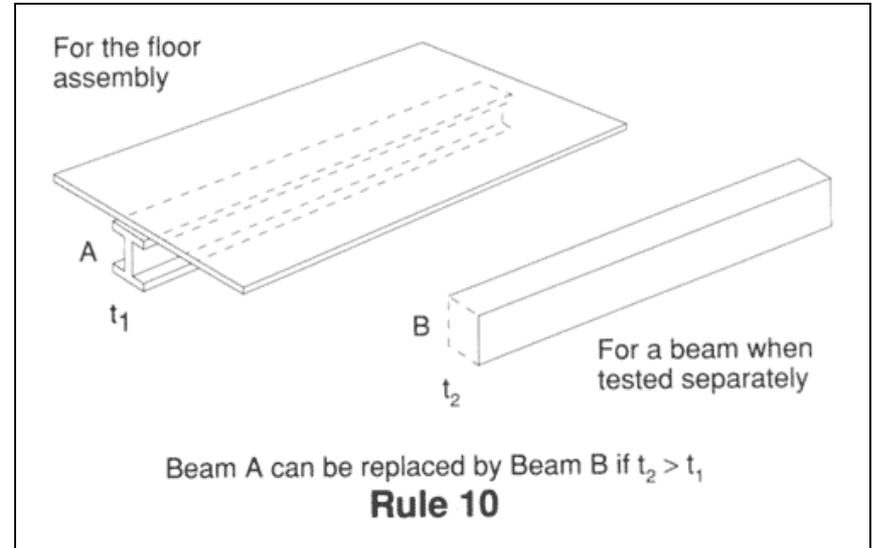
- The load-supporting elements (beams, girders, joists, etc.) of a floor, roof, or ceiling assembly can be replaced by such other load-supporting elements which, when tested separately, yielded fire endurance's not less than that of the assembly.

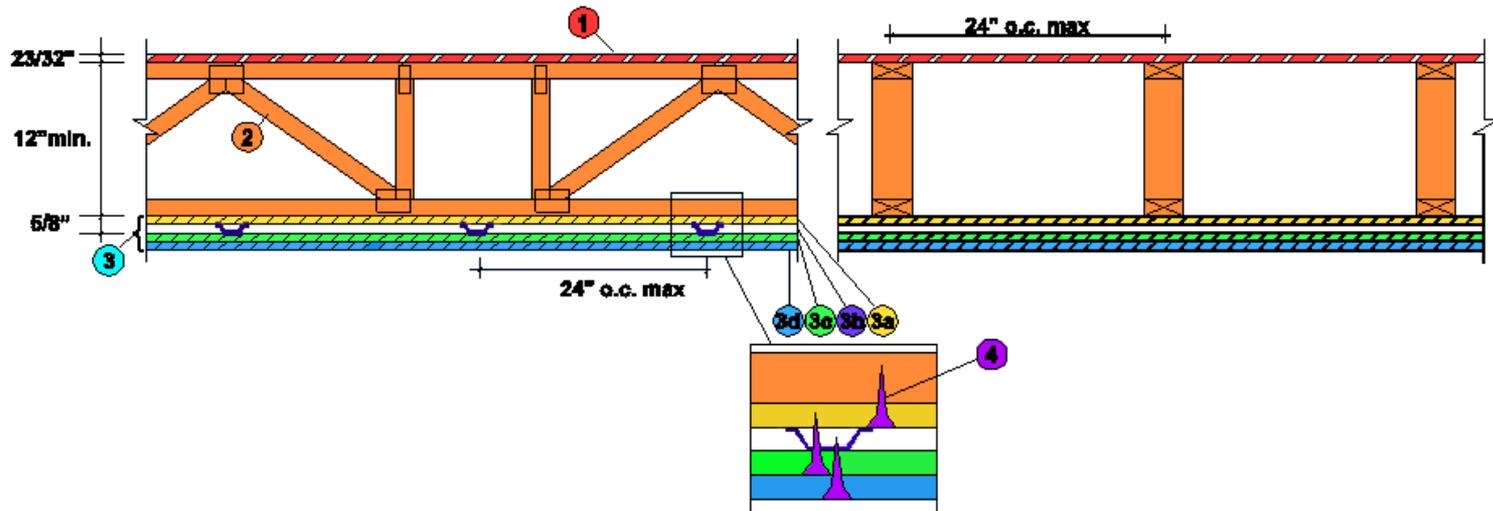
- Uses Harmathy's Rules
- Component times are additive.
- Uses Test Data to Confirm Performance

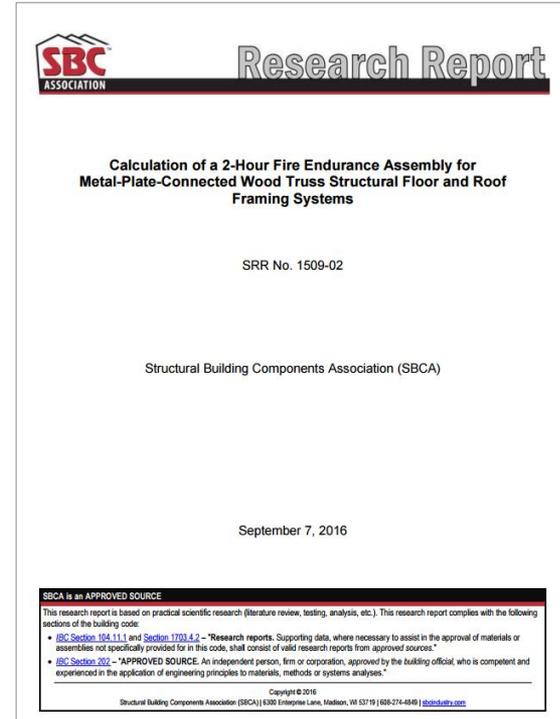
- The assembly summary is as follows:
 - Finish floor = 5/8" sheathing - Plywood or OSB
 - Structural members = wood truss, Minimum 12" deep, Maximum 24" on center
 - Ceiling membrane = 3 layers 5/8" Type C gypsum wallboard, Furring channel between layer 1 and 2.
- Note that the 40 minute value given for a single layer of 5/8" Type X gypsum would be exceeded both by the use of enhanced type X plus the use of multiple layers plus additional value for the furring channel and air space.
- See [SRR 1509-02](#) for complete details

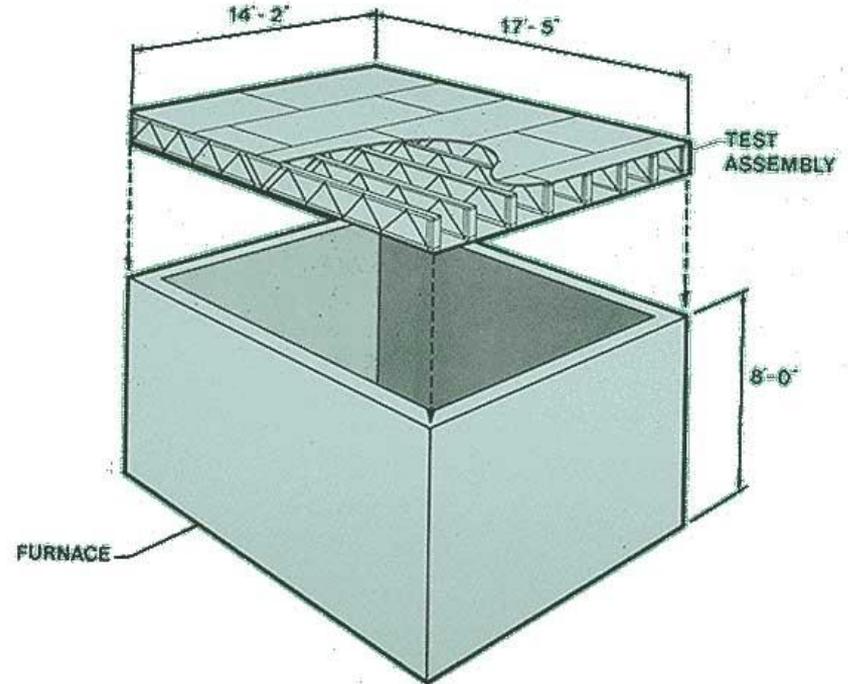
- Let us take a look at how a floor truss assembly was tested.
- For all full-scale fire endurance assembly testing the test assembly is designed for a 14' x 17' furnace.

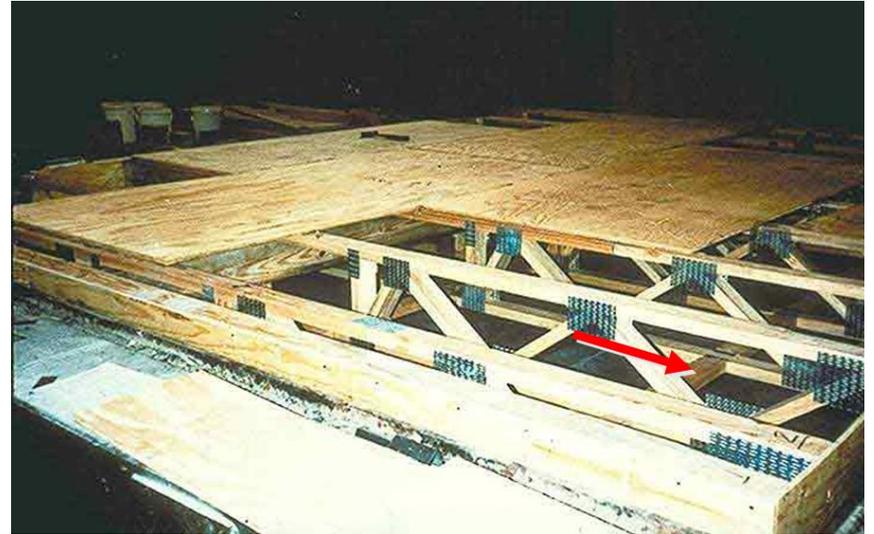
- For each ASTM test a representative assembly is constructed.
- This is a metal plate connected wood truss assembly test just prior to the sheathing being finished.
- This test is PFS 86-10 on which GA FC5517 is based.
- Although the following slides show wood floor truss testing, the process would be similar for any product.
- Note the 2x4 wood blocking required for backing the gypsum butt joints in this particular assembly.

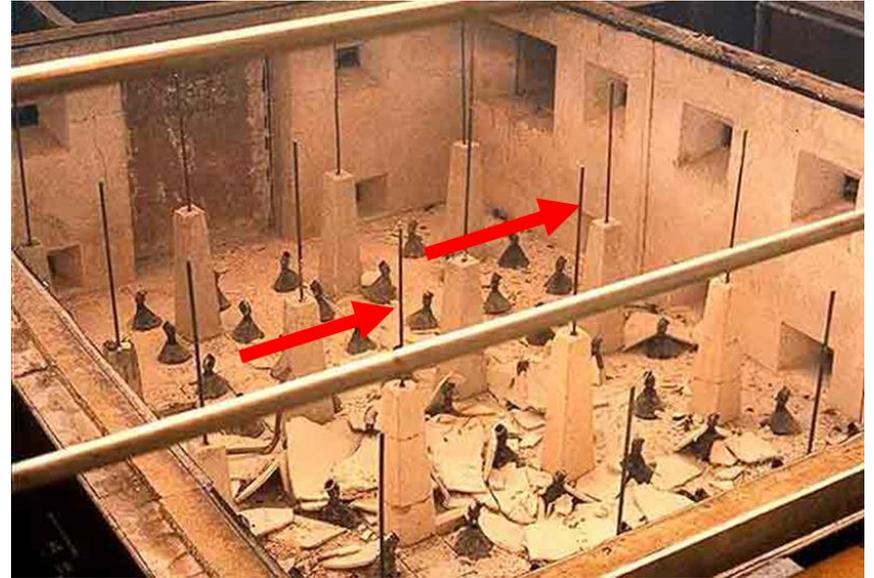
- In the test furnace one can see:
 - The gas burners at the bottom.
 - The long poles are the thermocouples that measure the temperature and control the amount of gas added to ensure that the ASTM E119 time temperature curve is followed throughout the test.

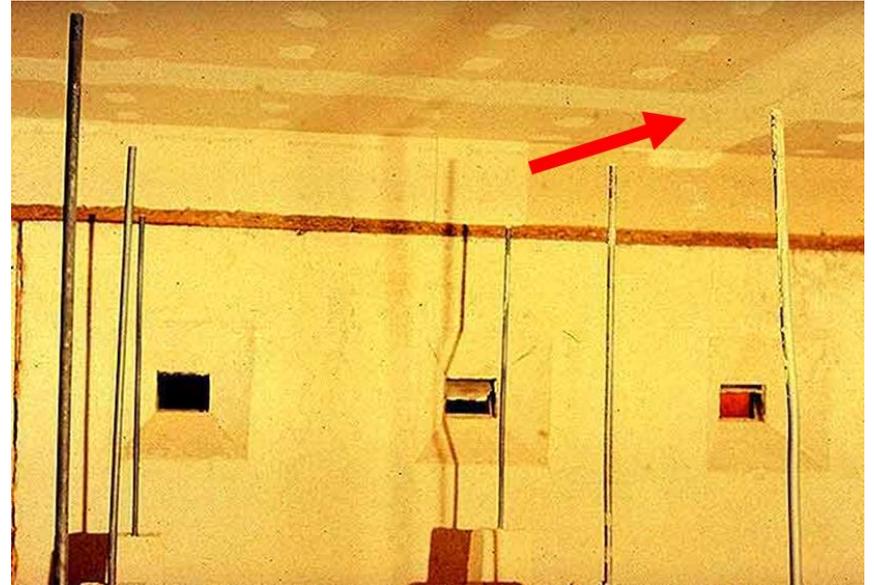
- The gypsum ceiling is installed to the assembly specifications and all joints are taped and mudded and all screws are mudded as well.

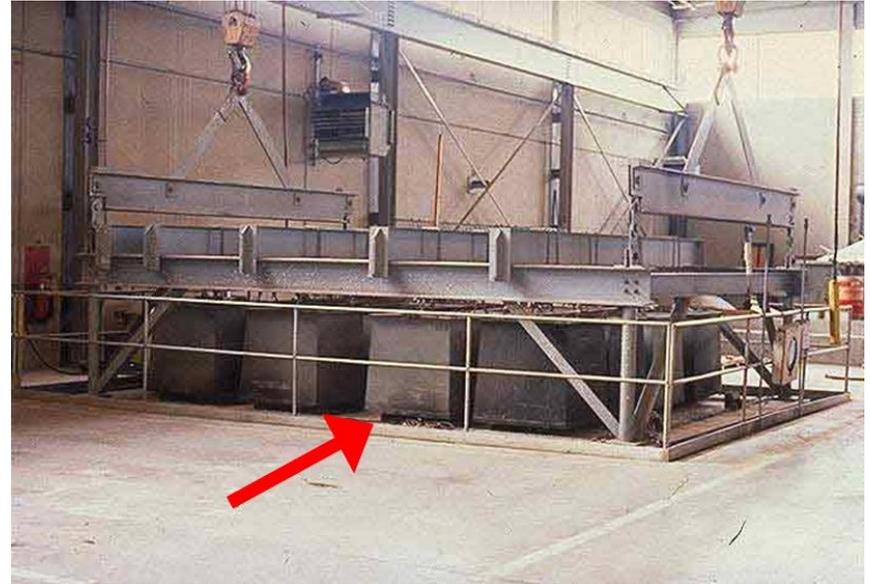
- This shows the assembly with the load applied just prior to the test being started.
- A unique feature of the ASTM E119 test is that the assembly is loaded to its full design capacity.
- The rectangular containers filled with water apply the loads to the assembly.
- It is interesting to note that the typical residential floor system in our industry is designed to carry 40 psf of live load.
- The typical actual live load in a residential floor is about 11.35 psf.
- The typical full design live load or total floor live load capacity used in a fire test assembly is 60-70 psf.

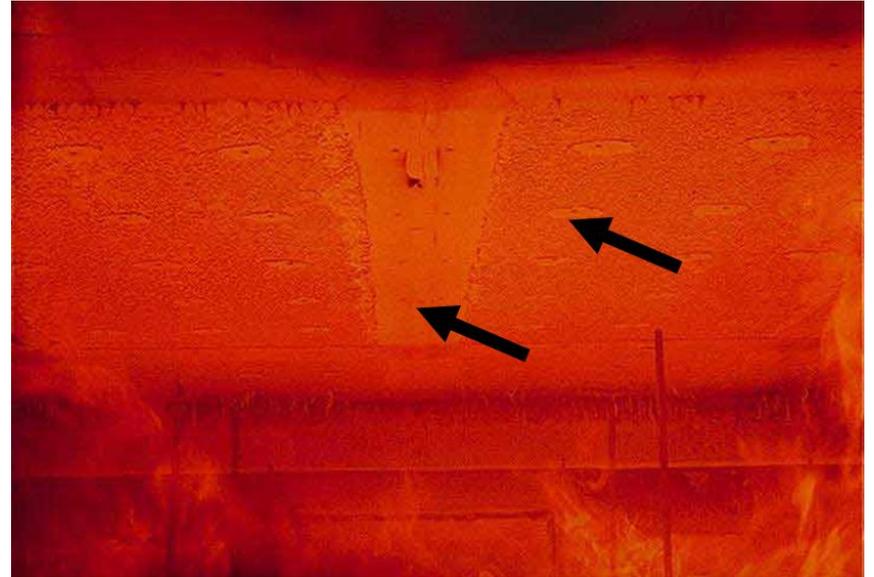
- This is a view inside the furnace at about five minutes into the test.
- One can readily see that the gypsum paper has already burned off.
- The mud and tape is still on the joints and screws.
- The temperature is well in excess of 500°F at this point.

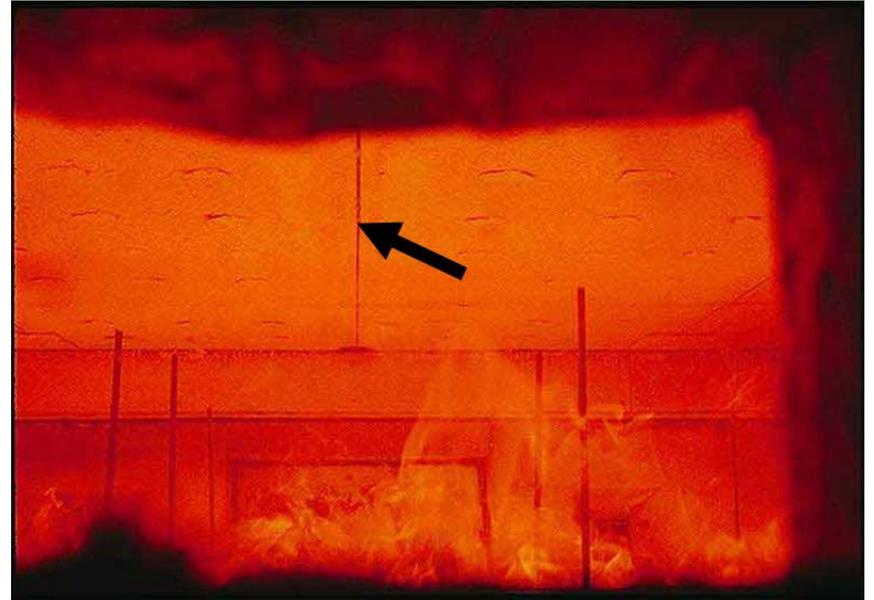
- This is the assembly at about 10 minutes into the test.
- Notice that the joint compound and tape covering the joints has now fallen into the furnace.
- This allows heat to transfer into the plenum space.
- It is at this stage that the temperatures begin to rise in the plenum space causing structural members to show the structural degradation effects of higher temperatures.

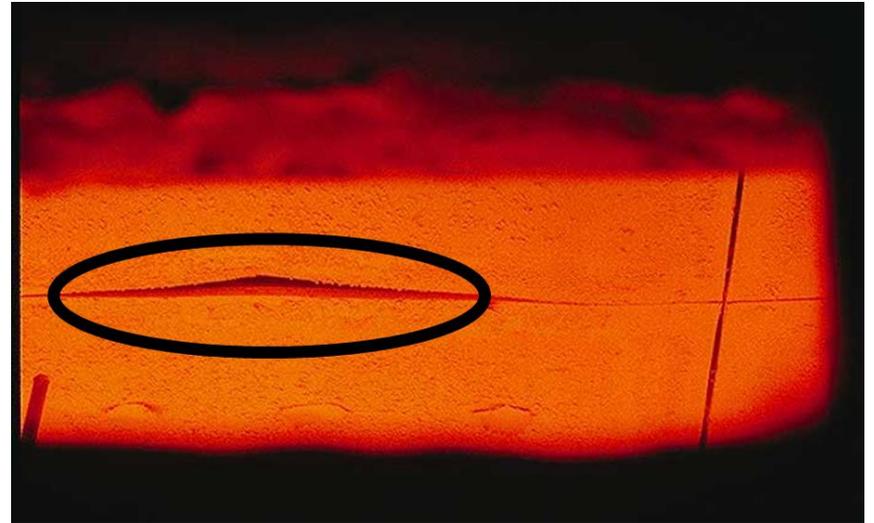
4.7 About 25 minutes into test

- This is the assembly at approximately 25 minutes into the test.
- Notice that the gypsum wallboard has begun to show signs of stress under the fire conditions due to the water in the gypsum wallboard evaporating and causing the gypsum to shrink.
- For any assembly to achieve a 1-hour rating it is critical that the gypsum stays intact for at least 30-40 minutes or more.
- Once the gypsum fails there is rapid failure of structural members.
- Because the furnace is at such a high temperature, most structural members will fail within 15 minutes after the gypsum falls off.

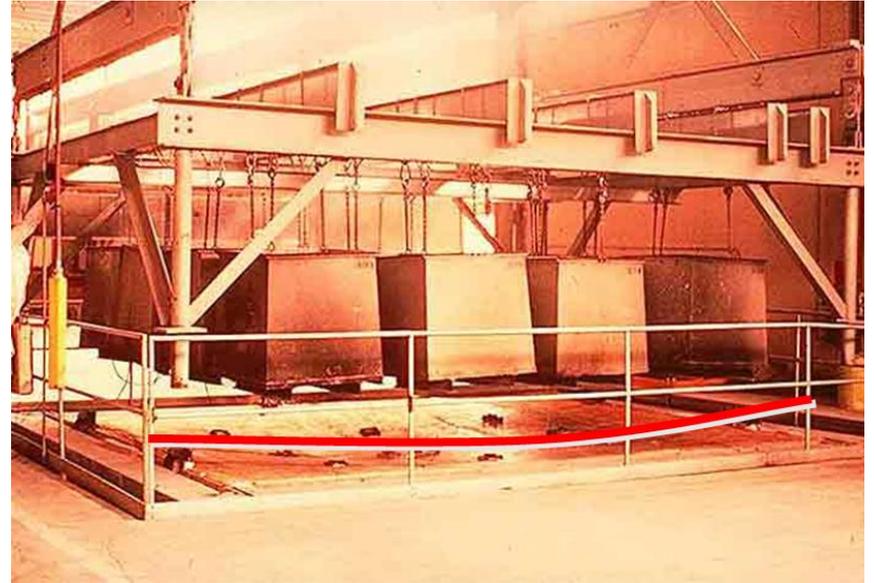
4.8 Load Application

- Note the curvature of the floor system after the completed test.
- Toward the end of this ASTM E119 fire test there is a high degree of visible warning prior to failure.

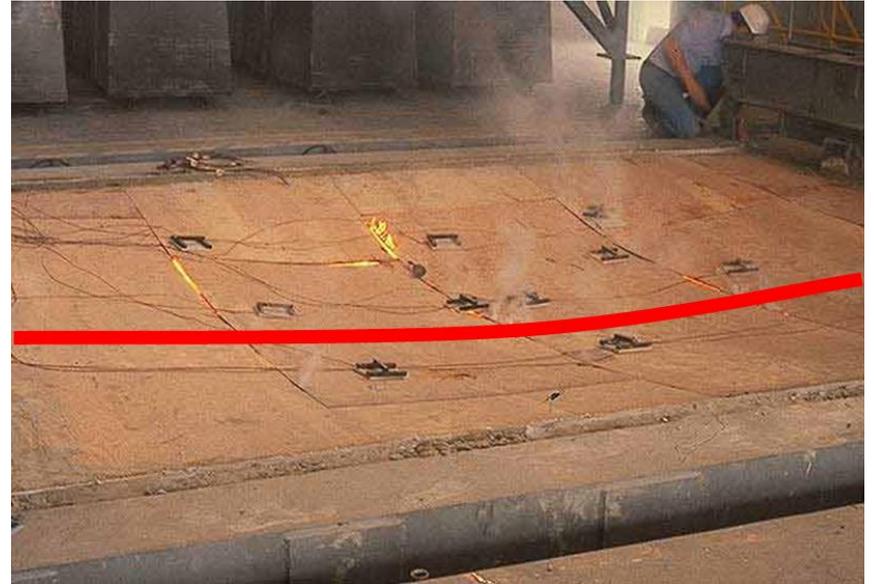
4.9 After 60 minutes

- This immediately after the one-hour test is completed and the loading buckets have been pulled away from the assembly.
- Notice the severe deflection of the structural members in this assembly which means that structural collapse was the failure mode.
- In real-life, however, the visible deflection would be much less because there may be very little live load actually applied to the structure.

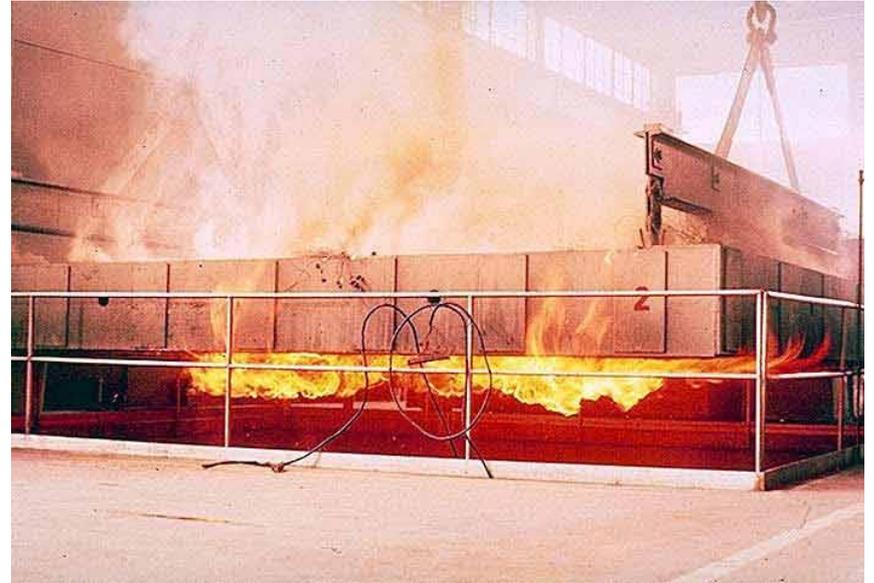
4.10 Lifting after 60 minutes

- As the fire endurance assembly is pulled up and off from the furnace, severe burning of the assembly occurs due to the flood of oxygen.
- When viewing the assembly after the fire has been extinguished, consideration needs to be made for the additional 10-15 minutes of burning after the test has completed.

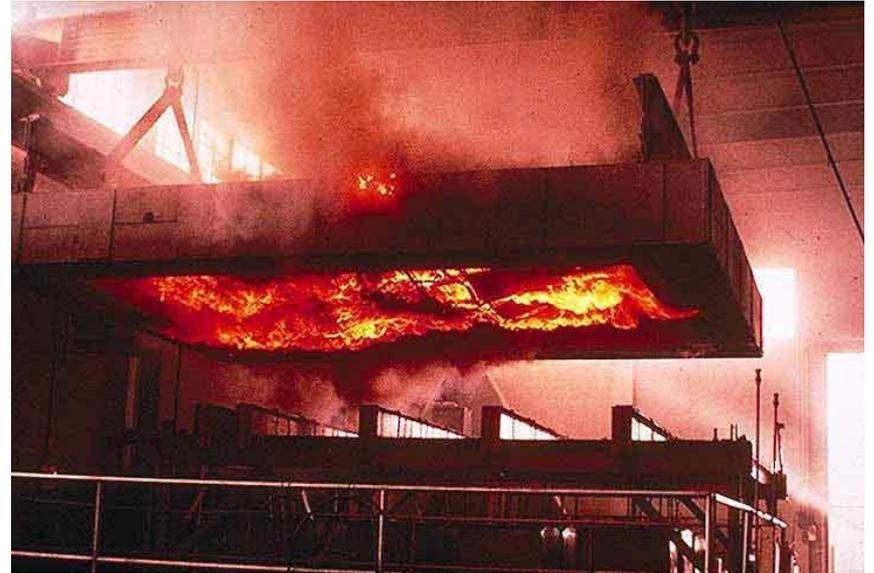
4.11 Lifting after 60 minutes

- The assembly is being raised into a position so that the fire can be extinguished.

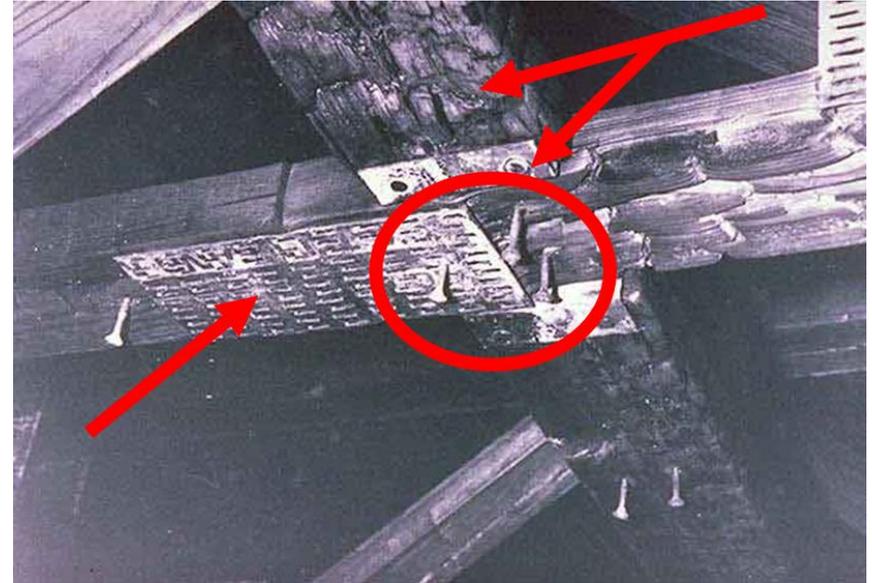
5.0 Truss splice plate after test

- This is a truss splice plate in the bottom chord of the truss after the test assembly has cooled down.
 - The plate is intact except for the charring of the wood around it.
- The screws in the truss plate and the bottom chord are the screws that were holding the gypsum in place.
 - In this case the charring of the wood did not go deep enough to cause the splice plate to fail.
- The wood blocks and metal clips are not part of the truss system.
 - They are a part of the tested assembly and are used to provide additional support for the end joints of the gypsum sheathing.
 - This blocking is not required in all fire rated truss assemblies.

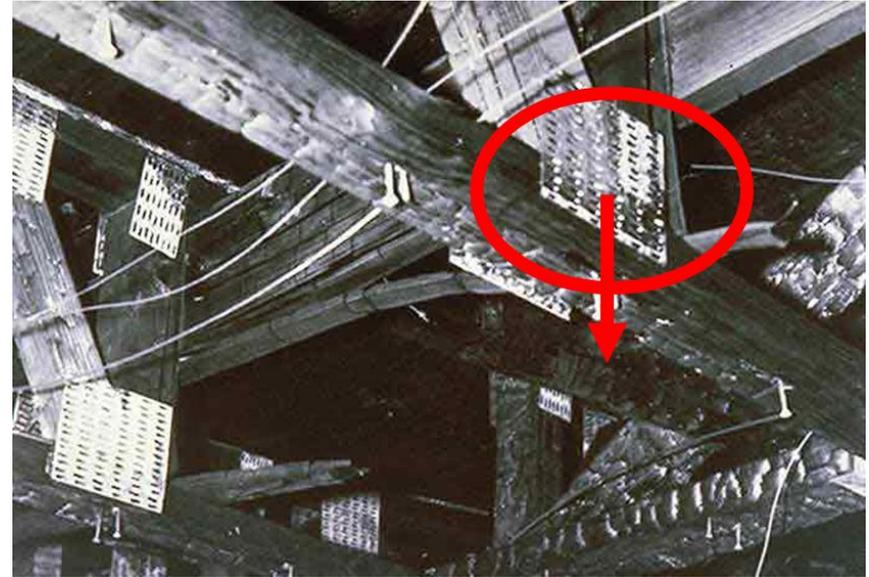
5.1 Trusses after the test

- This is the same assembly showing the structural failure location.
 - Notice that the truss plate at the joint location has curled somewhat away from the bottom chord.
 - This shows the typical withdrawal resistance failure mode of the truss plate as the bottom chord pulls away from the web members or conversely the web members pull away from the bottom cord under the applied loads.
 - The plate retains its curled shape due to the softness of the steel under the high temperatures and then it become hard again when water was applied to the assembly after the test was completed.

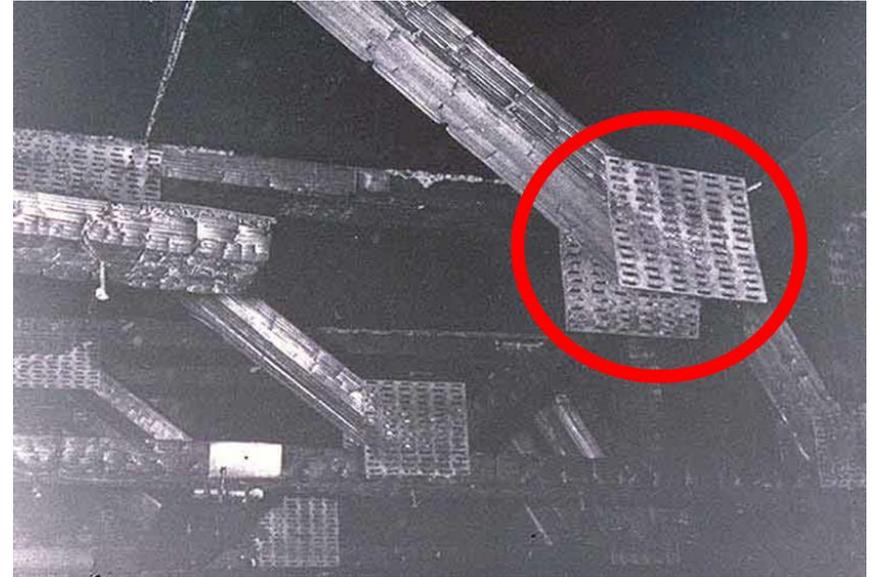
5.2 Trusses after the test

- This is another of the structural failure locations.
- Here the bottom chord has completely pulled away from the web member joint.
- Again the plate is curled slightly due to the bottom chord pulling away from the joint under the applied load.

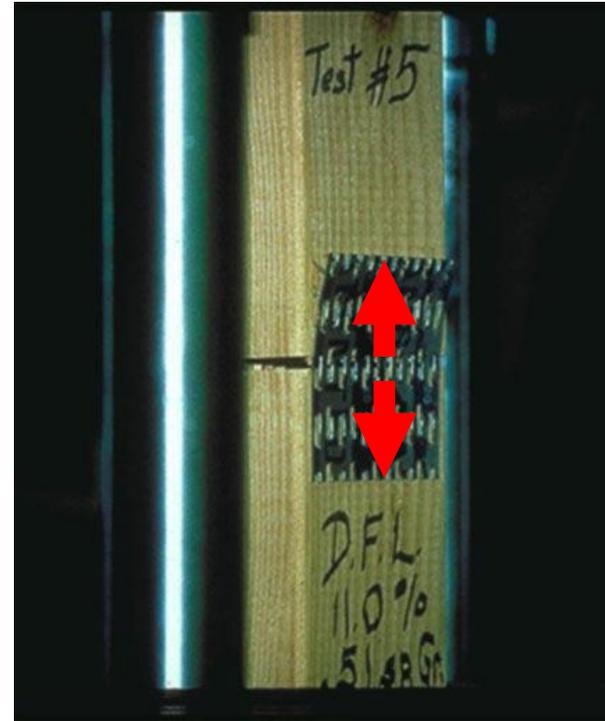
5.3.1 Connector Plate Testing

- This demonstrates withdrawal resistance failure mode
 - Notice how the plate has begun to pull out of the wood after the load is applied.
 - The plate has taken on a cupped shape.

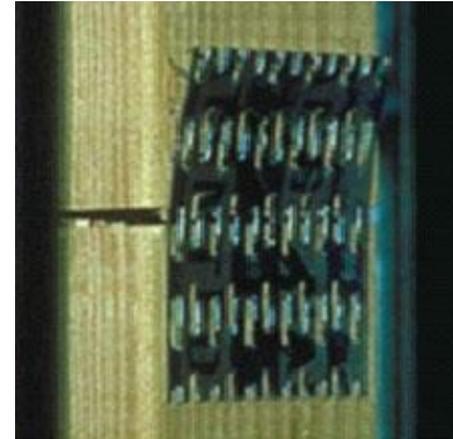
5.3.2 Connector Plate Testing

- This is a close-up of the plate in the previous slide.
- The withdrawal of the plate from the wood under the applied load caused the plate to cup.
- No fire was involved in this test.
- However, because this withdrawal is observed at fire scenes, the assumption is made that the plates curled and withdrew because of the fire or heat applied to the plate.
- The plate withdraws because of excessive loads applied to the truss in a location where it was not designed to carry that load.
- This excessive load could be the result of a weakened truss member or additional load from debris.
- When trusses are no longer able to carry the loads applied to them, the truss plates withdraw from the joint – some even fall to the ground.

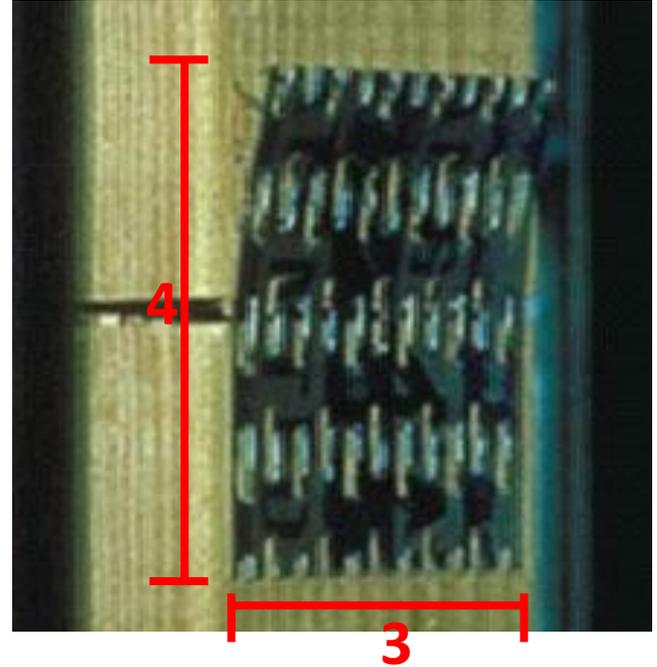
5.3.3 Connector Plate Testing

- The typical truss plate in our industry has a 0 degree design withdrawal resistance of 200 psi
- The joint shown above with a 3x4 plate has a design capacity of about 2400 lb.
- And with a factor of safety of 3.2 has an ultimate strength capacity of about 7680 lb.

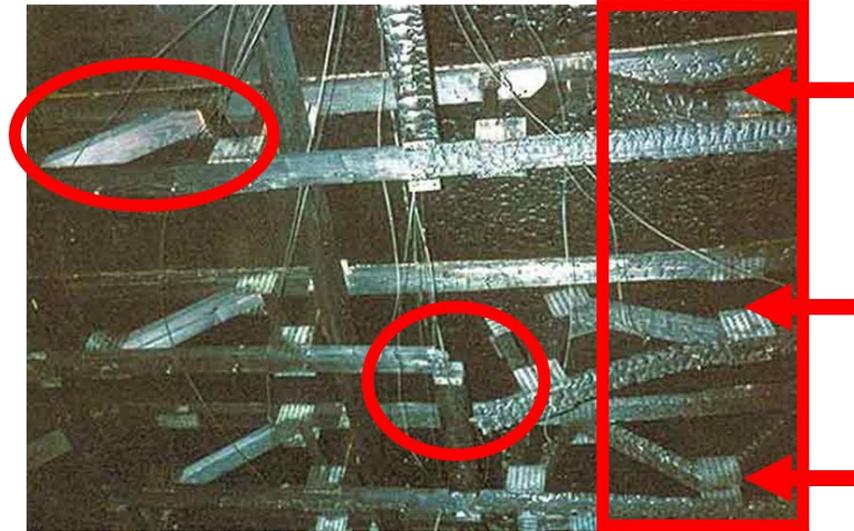
5.4 Trusses after the test

- This is a broader view of the trusses after the test.
 - Notice in the center of the photograph that a splice plate failed causing the truss to fail completely and severely deflect at that failure point.
 - In the upper left-hand corner there's still lumber that has remained un-charred even though this assembly burned for more than 60 minutes.
 - On the right, there has been severe charring of the wood, but all the truss plates remain attached to the web and chord members.
 - The truss at the top of the photograph, in all likelihood, is still carrying some amount of load. When this truss failed it caused the adjacent trusses to carry more of the load.
- All the trusses in the assembly would fail eventually had the fire been allowed to burn long enough.

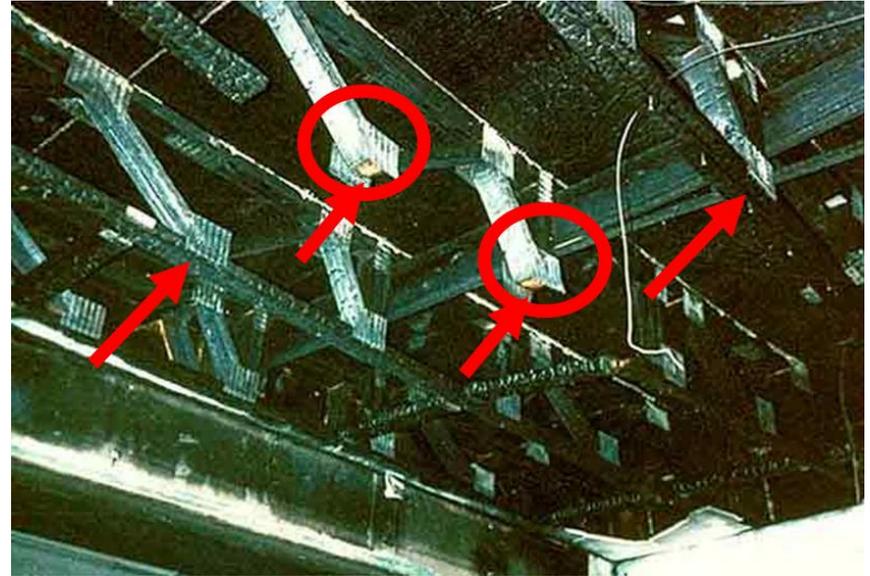
5.5 Trusses after the test

- This is another view of a bottom chord failure in this truss system.
 - Notice the plates are cupped where the bottom chords pulled away from the web members.
 - Notice also the bright normal colored wood near each plate that has remained un-charred and still has load carrying capacity.
 - The trusses adjacent to the failed truss are still intact and retain some of their structural capacity, however, at this point probably not enough strength to be walked on.

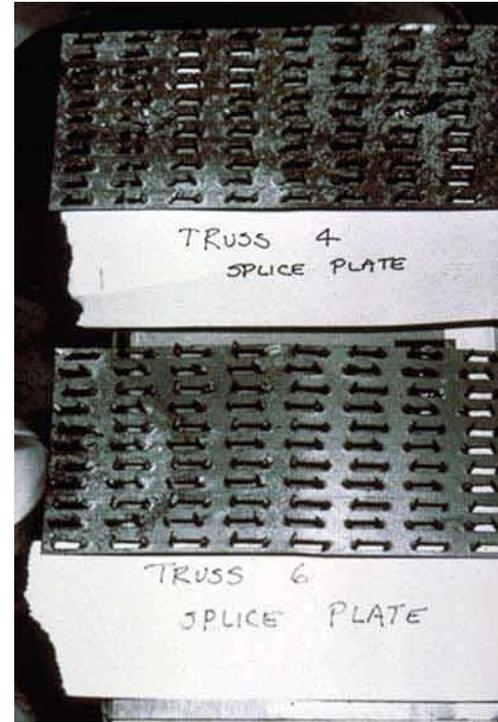
5.6 Truss plates after the test

- These are the splice plates from trusses 4 and 6.
- The plates show no distress and look no different from normal plates other than the charred wood remaining on the teeth and some discoloration.

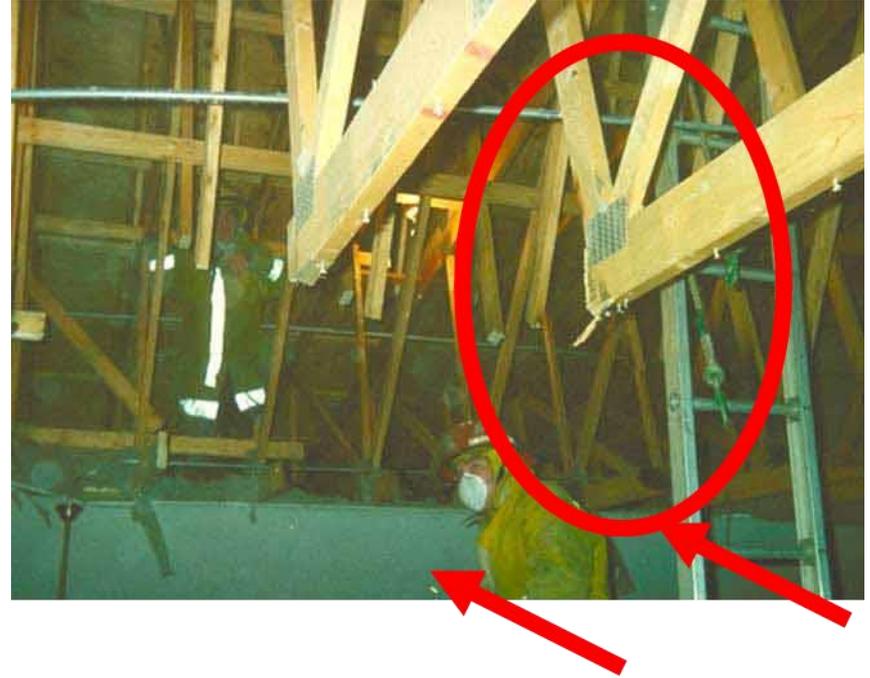
5.7.2 Church Fire

- In this case it was determined that the trusses were sturdy enough [oval] that the fire service personnel could work on the structure by standing within the trusses themselves as the only means of support.
- In this case [arrow] the trusses that are being cut are also supporting the weight of those that are standing inside of them, doing the cutting.
- Please note the location of the ceiling fan immediately below the firefighter's feet at the bottom left corner of the photo. The ceiling fans serve as a reference point indicating the ceiling ridge. [arrow]

- The following series of pictures are from a 1992 fire in a church in Marshfield, WI., where 66 foot scissor trusses were cut by the fire department.
- The fire started in the ceiling/roof cavity caused by a canister light fixture.
