**Fire Assemblies:
Performance and Application Using
Wood Trusses**

Overview

Revised 2/24/2017

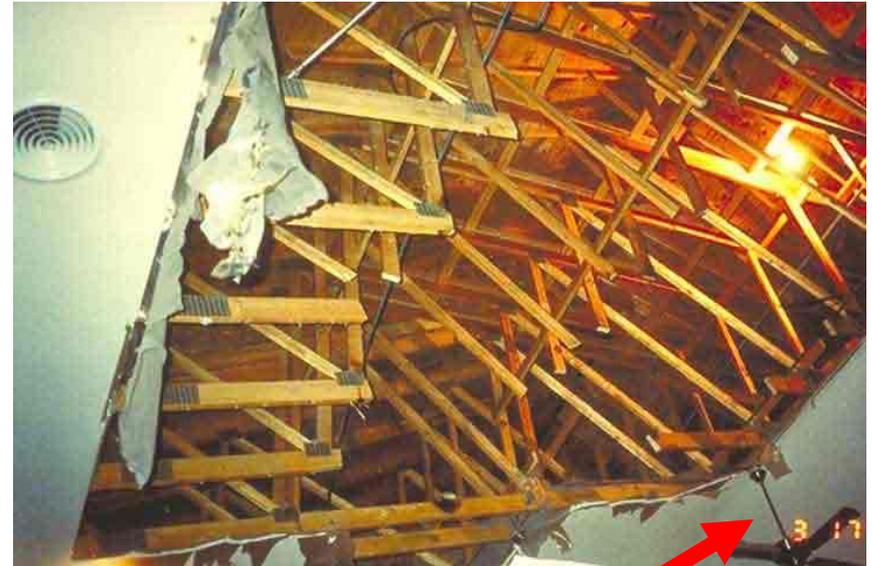
5.7.3 Church Fire

- This shows the completed cutting operation. There are a total of 11 trusses (22') whose bottom chords and web members have been cut out in order to stop any further spread of smoldering fire.
- Note again the ceiling fan in the lower right corner as a reference point.

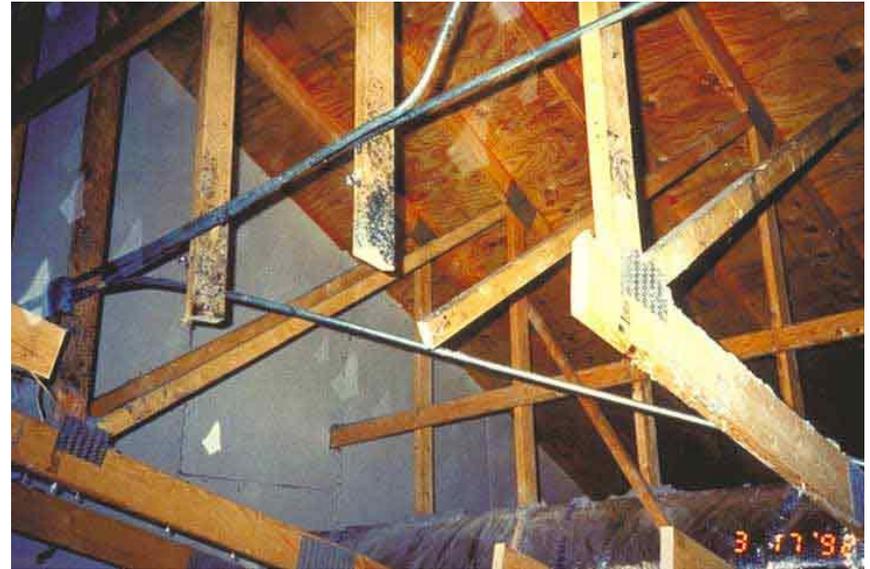
5.7.4 Church Fire

- Here is a close-up of the cut chord and web members and gives some indication of how much of the bottom chord and web members had to be cut to eliminate further smoldering.

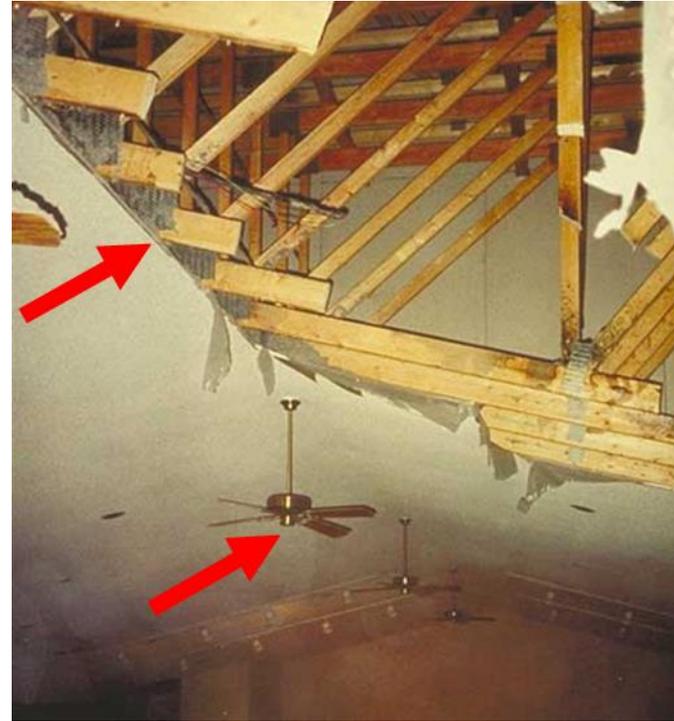
5.7.5 Church Fire

- This is another view of the cut out section of trusses.
 - Notice the ceiling fans are at the center peak of the bottom chords of the scissors truss. The trusses for this church sanctuary are 66 foot clear span scissors trusses
 - The area of burning took place just to the right of the bottom chord peak.
 - This center peak joint is the area of highest stress in the bottom chord of any scissors truss.

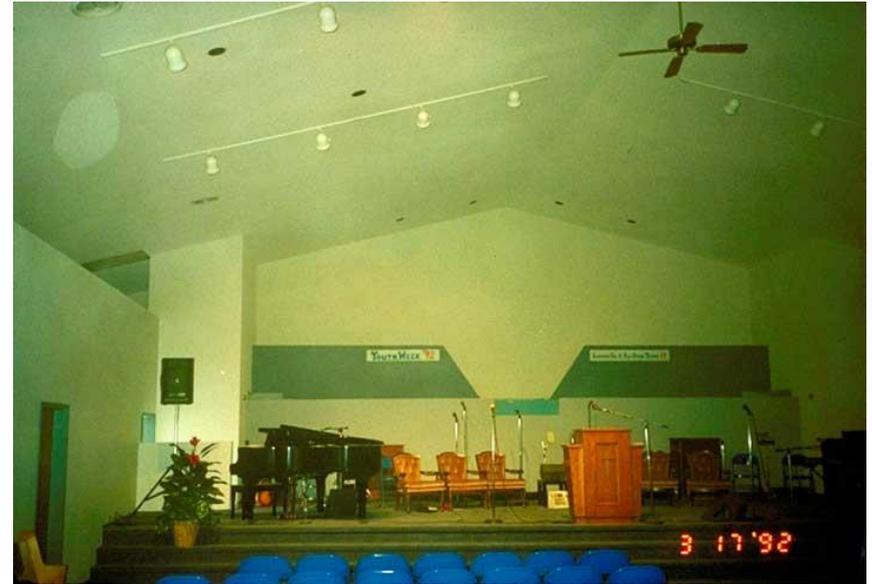
5.7.6 Church Fire

- All of the cut trusses were repaired by manufacturing identically configured sections of scab trusses that were slid in next to the original fire damaged trusses and nailed and bolted into place.
- Then the gypsum was replaced, and the ceiling was restored to its original condition.
- This is a great example of the extraordinary performance of trusses even when damaged by fire.
- It also demonstrates that trusses may be easier to repair than many people expect.

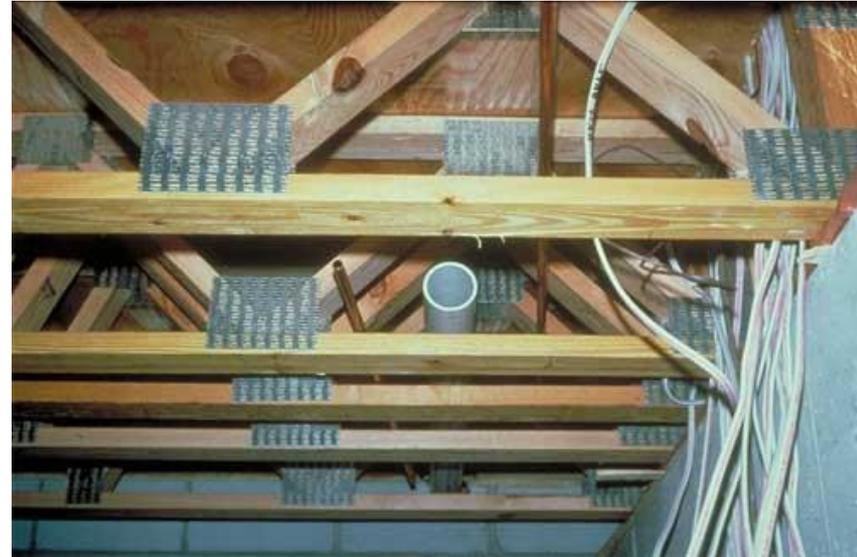
6.0 Unprotected Assemblies

- A key area of concern for the fire service is in residential basements where the floor framing often has no gypsum protection.
- Unprotected assemblies, like this, are allowed by code, in residential construction.
- Wherever a single layer of ½" gypsum is installed, it affords at least 10 min of fire protection (industry standards list the time at 15 min).
- There are no fire endurance assembly requirements for residential construction primarily because the model codes address fire spread between occupancies or containment within a compartment, and in single family dwellings there is only one occupancy.
- There is a scarcity of testing on unprotected assemblies because there is no testing requirement to use unprotected assemblies in a structure.

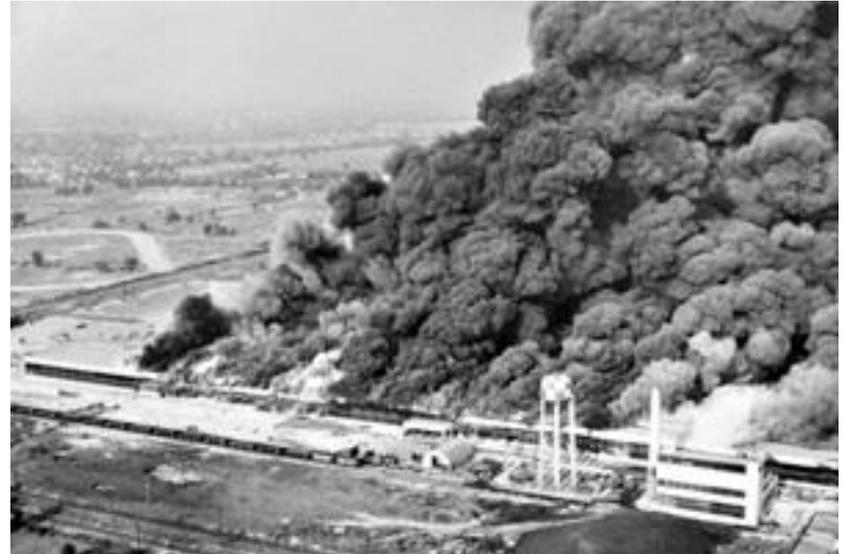
7.1 Non-Combustible Materials

- General Motors Plant, 1953
 - Non-combustible building & non-combustible contents, yet completely collapsed.
 - The fire was caused by a welder on the roof who ignited the roofing material.
 - The fire caused the steel to buckle after it exceeded 1000°F, causing the roof to collapse into the building pulling down the walls along with it.
