NATIONAL ENGINEERED LIGHTWEIGHT
CONSTRUCTION FIRE RESEARCH PROJECT

TECHNICAL REPORT:
LITERATURE SEARCH
&
TECHNICAL ANALYSIS

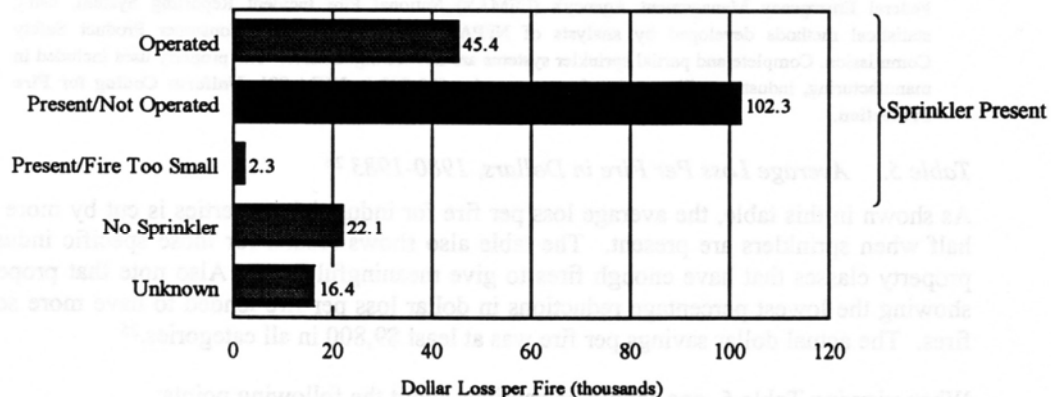
Note: Sprinklers are most often present in buildings with contents of high value. Therefore, dollar loss statistics can be misleading. Also, small losses may not be reported, which would skew the statistics.

Figure 8. *Sprinkler Performance in Non-Residential Structures: Dollar Loss per fire, 1987*²³

Figure 8 relates the performance of sprinklers in terms of dollar loss in non-residential fires.

It is clear from Figure 8 that when sprinklers operate properly, damage (as reflected by dollar loss) is reduced by more than 50%. One must be concerned, however, by the magnitude of loss when sprinklers are present and operate. The mitigating factor behind this high amount of loss is that sprinklers are most often present in properties of high value, and with contents of higher value. Historically, sprinklers are not provided in structures which are small in area or relatively low in value (e.g., single-family dwellings).

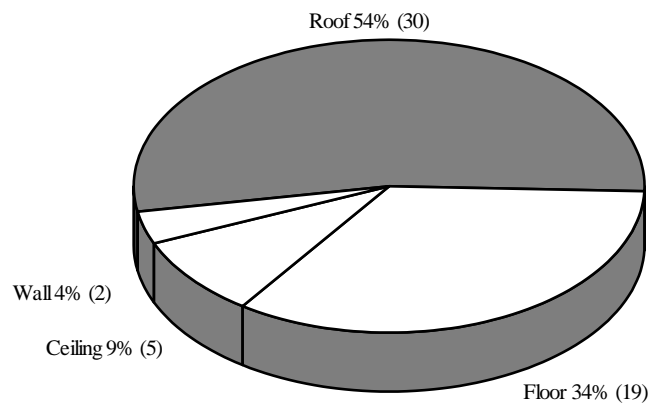
Figure 22. Building Components Involved in Firefighter Fatality ⁵⁰

The building components involved in the collapses were the roof (30 fatalities), floor (19 fatalities), ceiling (5 fatalities), and walls (2 fatalities). These data can be seen in Figure 22.

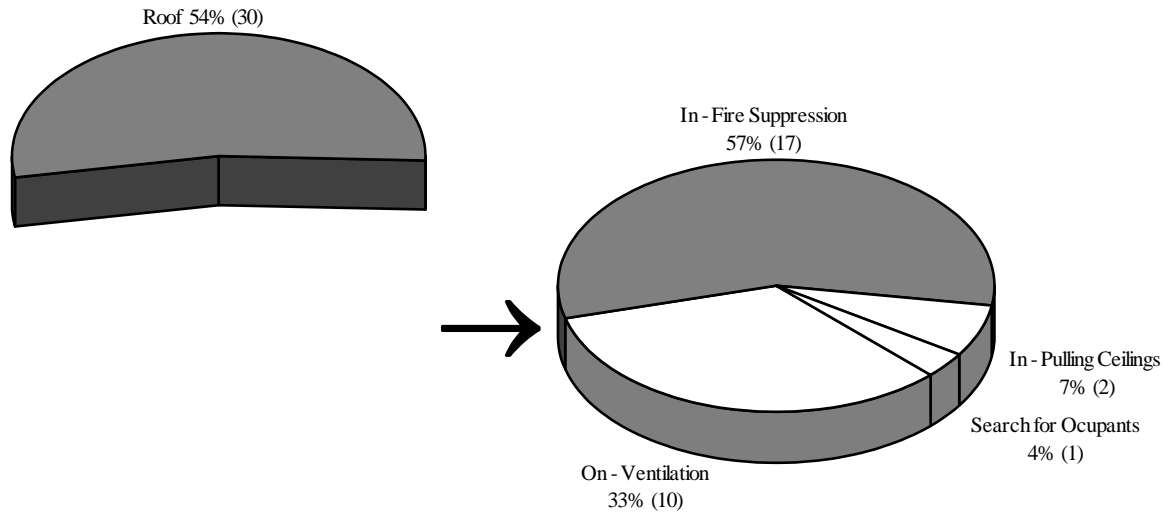
Figure 23. Firefighter Activity During Fatality-Causing Roof Collapse ⁵¹

The 30 fatalities in roof collapses occurred as follows: 10 of the victims were on the roof performing ventilation, 17 were inside performing fire suppression activities, 2 were inside pulling ceilings, and 1 was involved in a search for occupants. These data are shown in Figure 23:

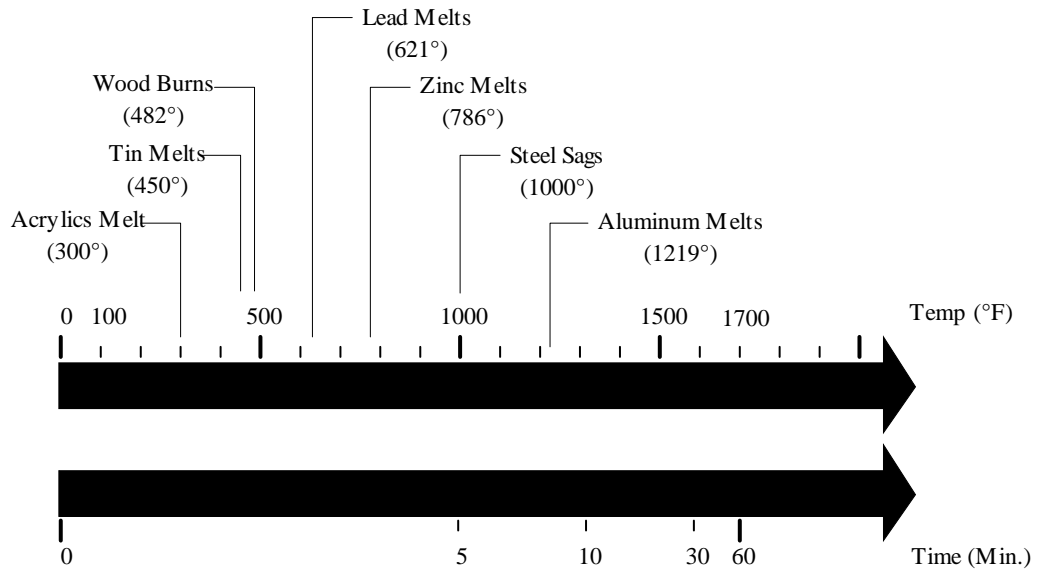
Figure 28. ASTM E119 Standard Fire Exposure⁴

A figure that shows the severity of the ASTM E119 time/temperature in terms of material properties has been prepared and is shown in Figure 28.

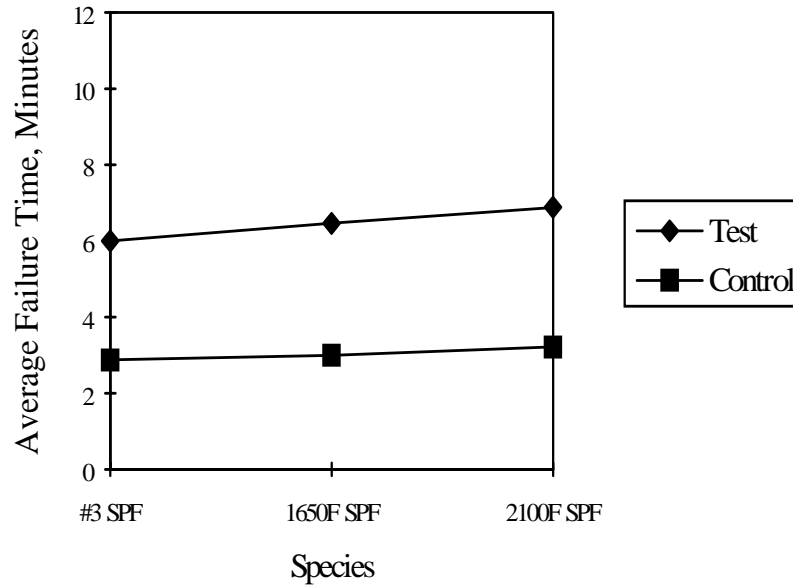
Figure 31. Average Failure Time for Horizontal Specimens

These data from the table above are represented graphically in Figures 31 and 32:

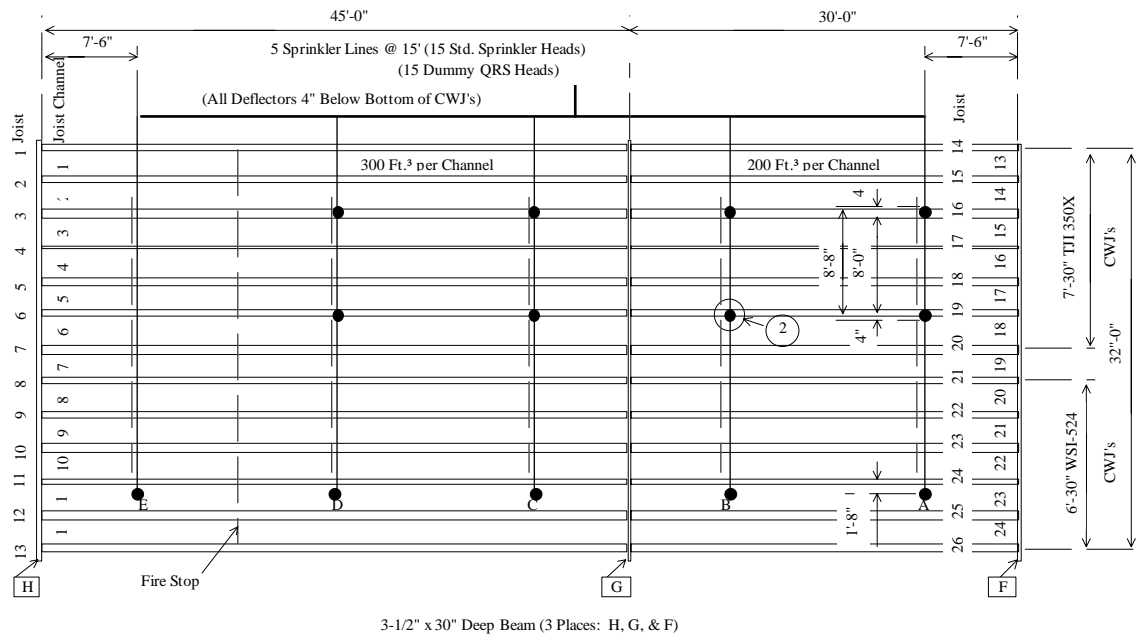
Figure 41. Plan View of Test 2

Test 2: The fire source was located under the center-most sprinkler head of the branch line next to the center beam under the 30 ft. joists. This fire location was selected in response to a concern that the critical fire location was beneath one sprinkler. Active standard response sprinklers were used. The sprinkler head deflectors were located 34 in. below the bottom of the deck. Fifteen standard response and fifteen quick response sprinklers were deployed.

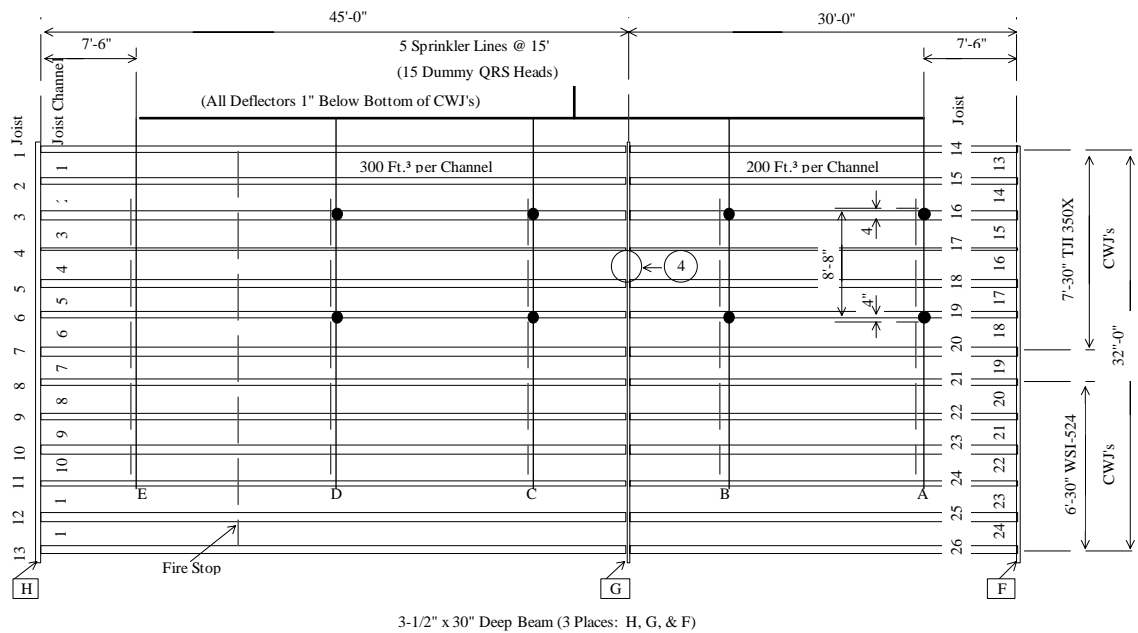
Figure 45. Plan View of Test 4

Test 4: This test was developed based on a concern that the critical fire location was directly below a firestop. The rest was similar to the general assembly, except that branch lines were located 32 in. to the side of the original locations. The sprinkler head deflectors were located 31 in. below the bottom of the deck. Fifteen inactive quick response and eight active standard response sprinklers were deployed.
